# **Intrusive Inspection Project**

**Christopher Smith, Chairman  
Intrusive Inspection Working Group**

**FAA Inspectors/Engineers EAPAS Workshop  
November 5-8, 2001**

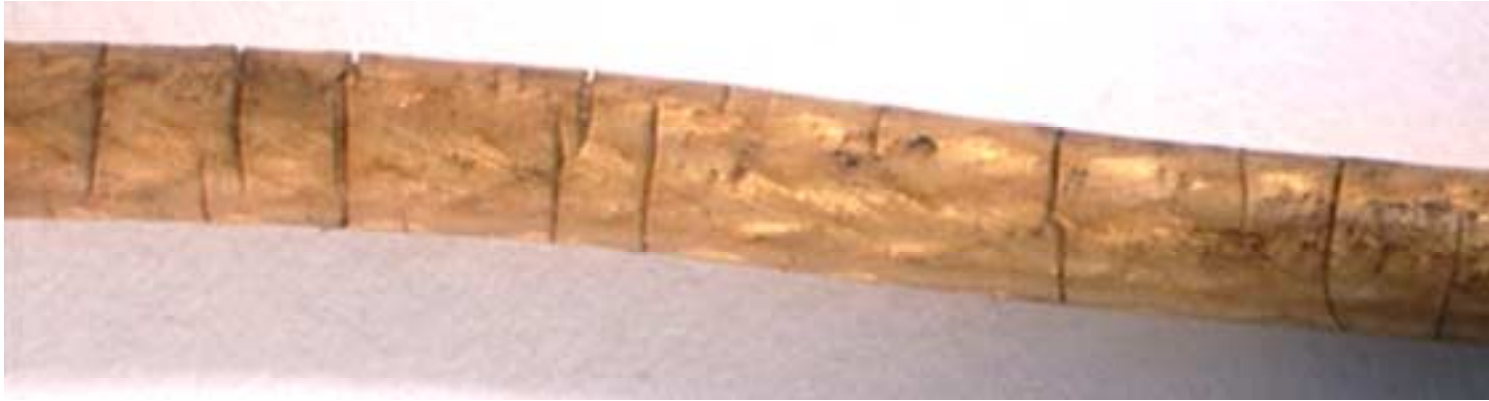
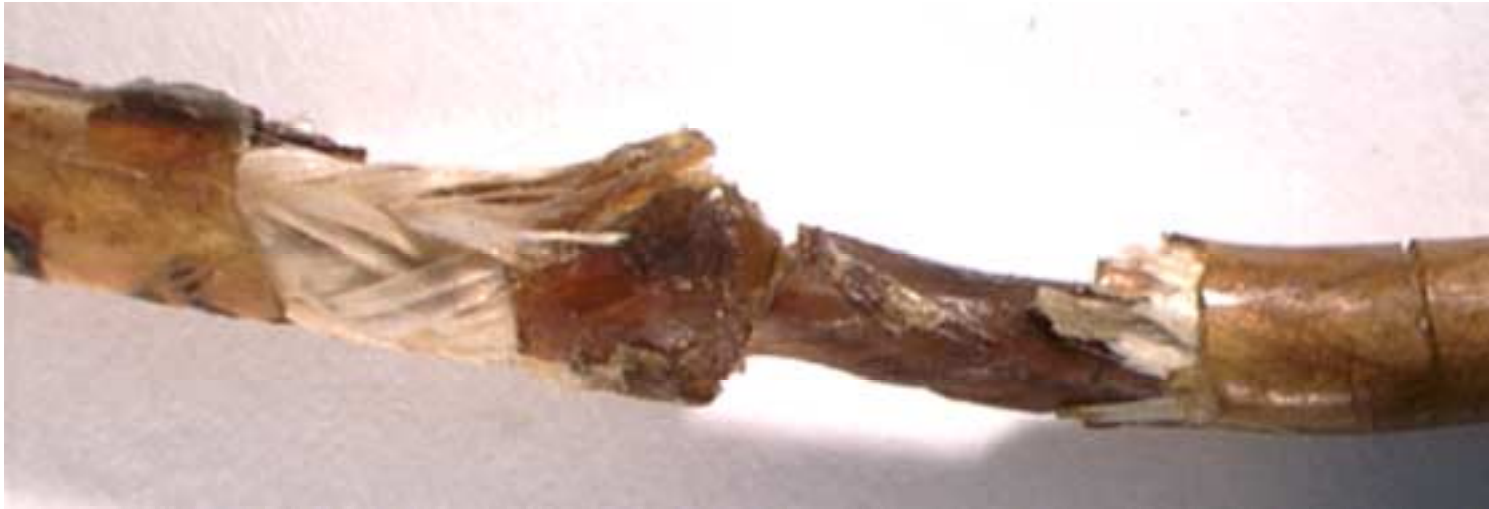
# Cracking

**Cracked Insulation:** A breach in the wire insulation that does not include breaches resulting from the direct physical contact or traumatic force (e.g. knife cut, or tears).

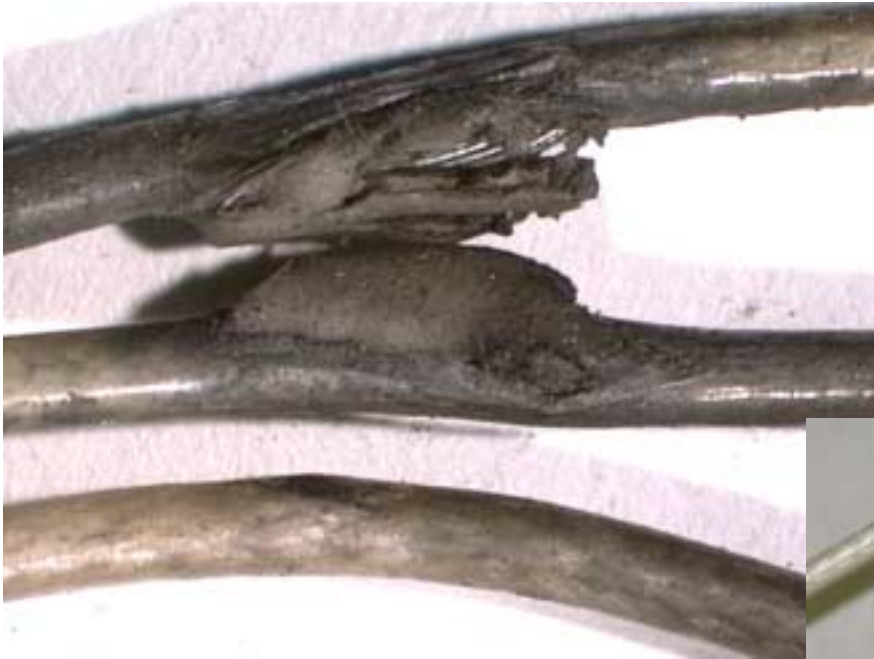
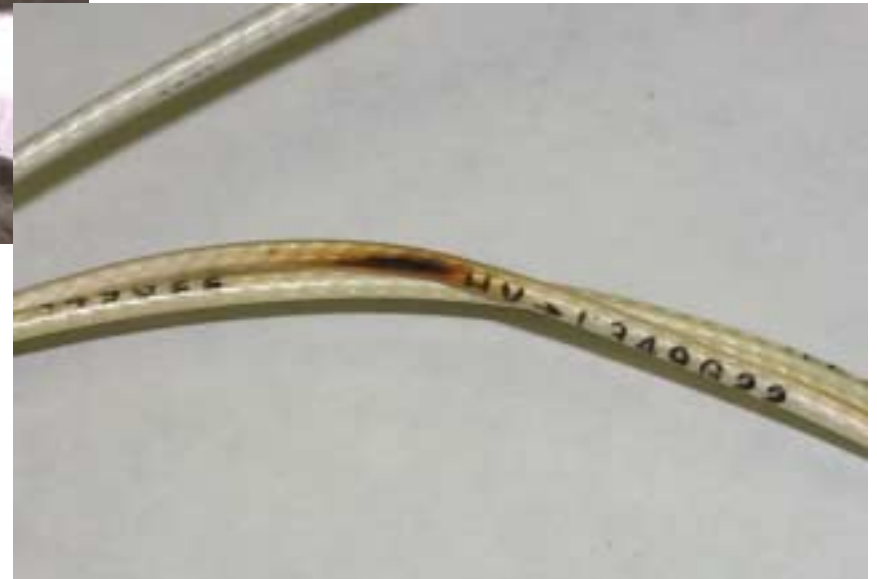
# Burnt, Heat-Damaged Wire

**Heat Damage or burnt wire:** Thermal damage to insulation resulting from the presence of elevated temperature due to internal or external heating.

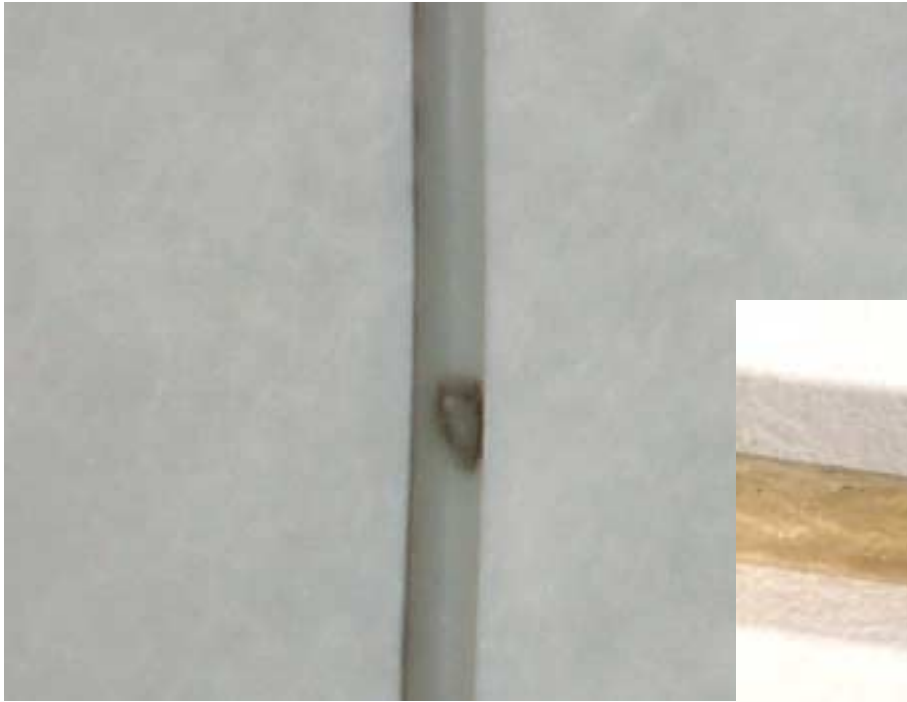
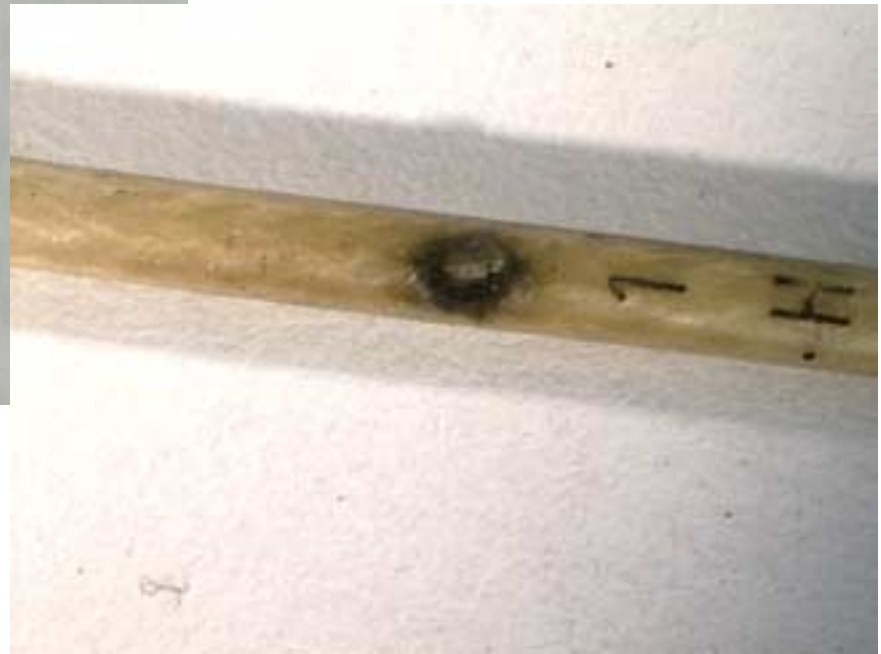
# Evidence of Arcing

**Arcing:** One or more instantaneous electrical discharges evidenced by burnt spot on one or more wires and melted conductors

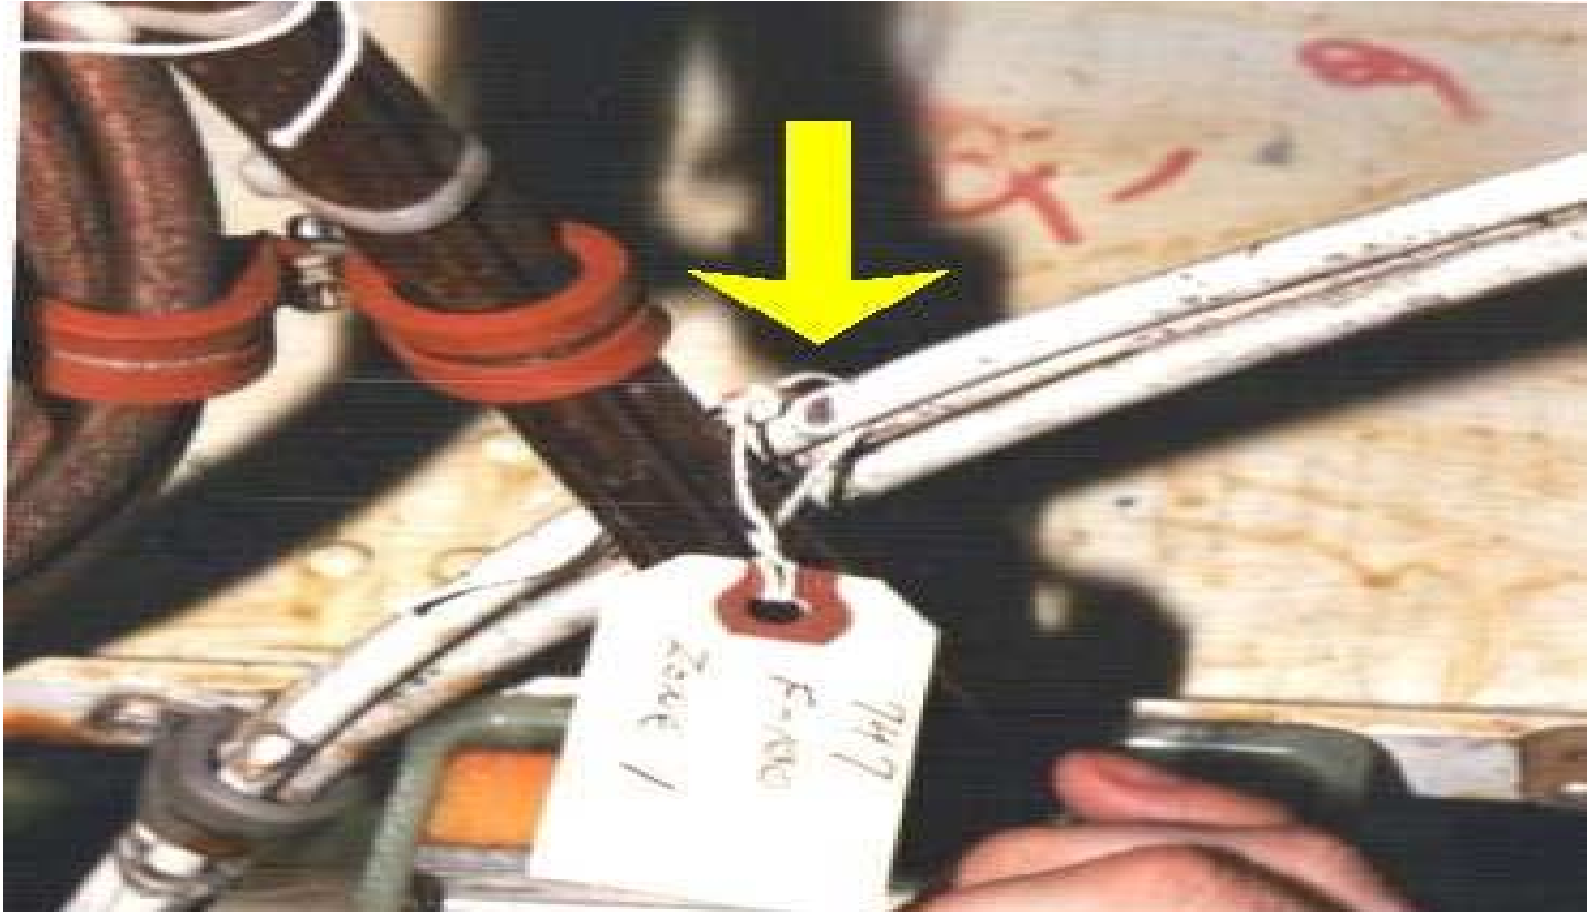
# Chaffing

**Vibration Damage/Chafing:** Insulation wear (material loss) resulting from the repeated application of a force which if applied only once would not result in noticeable damage.

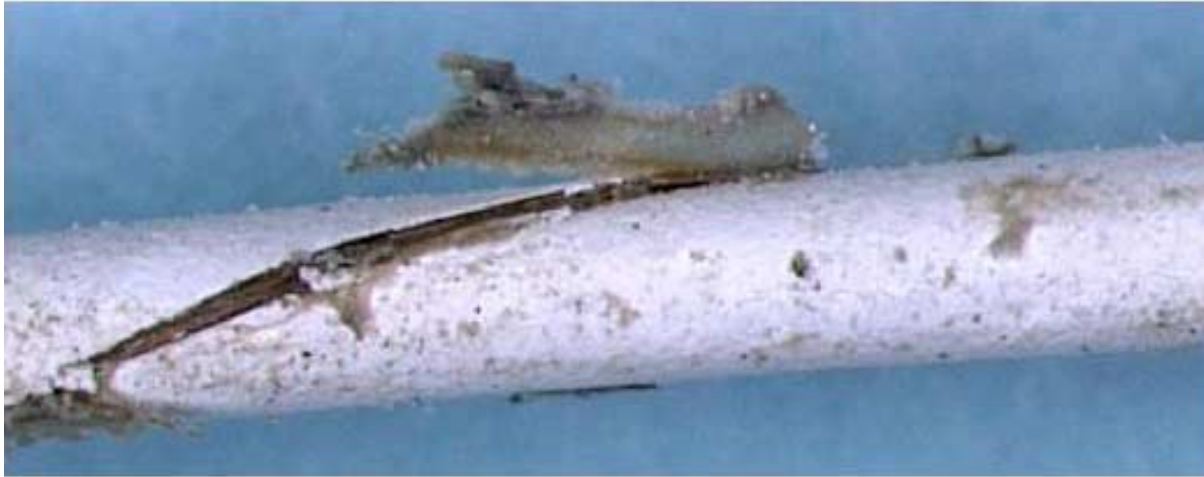
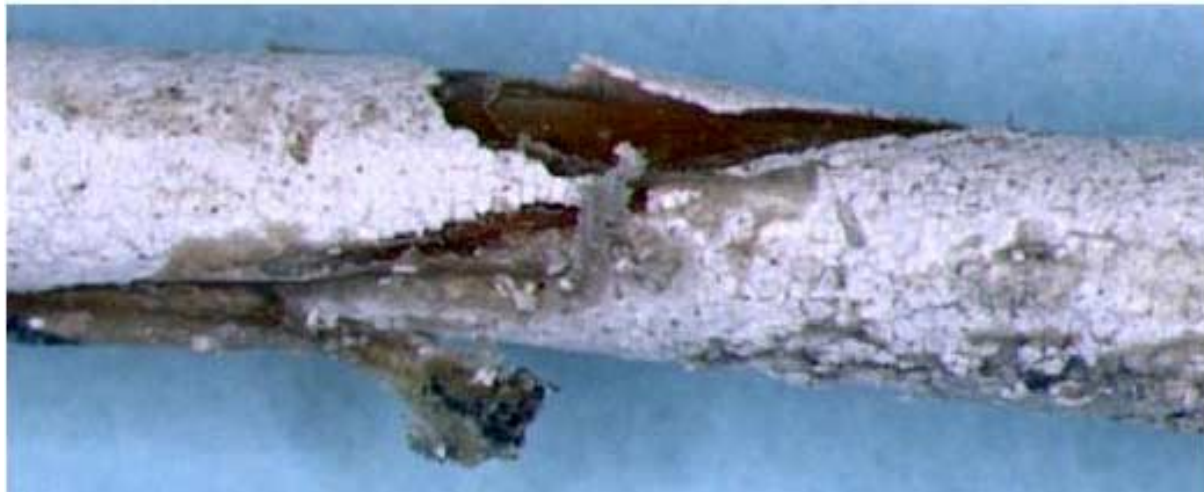
# Delamination

**Delamination:** The unraveling of a tape-wrapped insulation. The separation of layers of insulation in a multilayered construction.

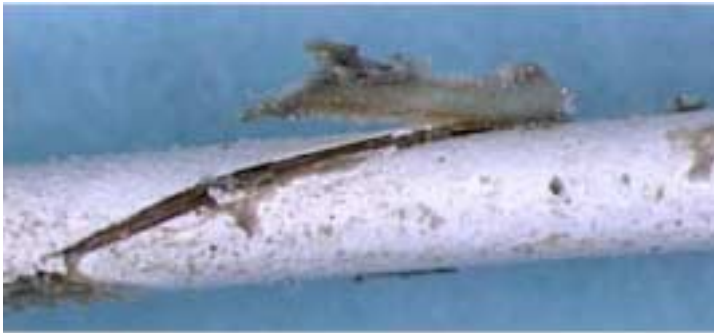
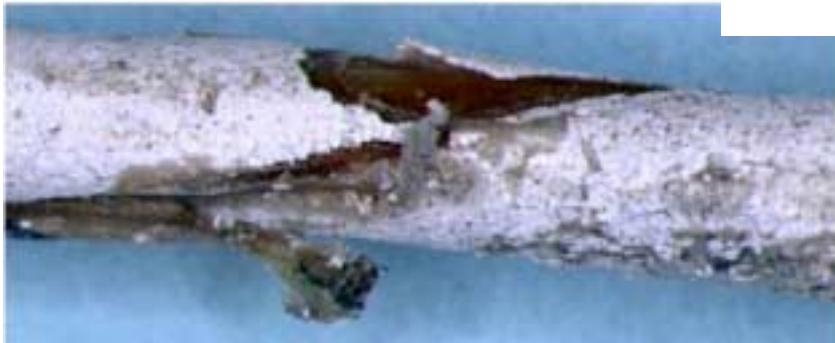
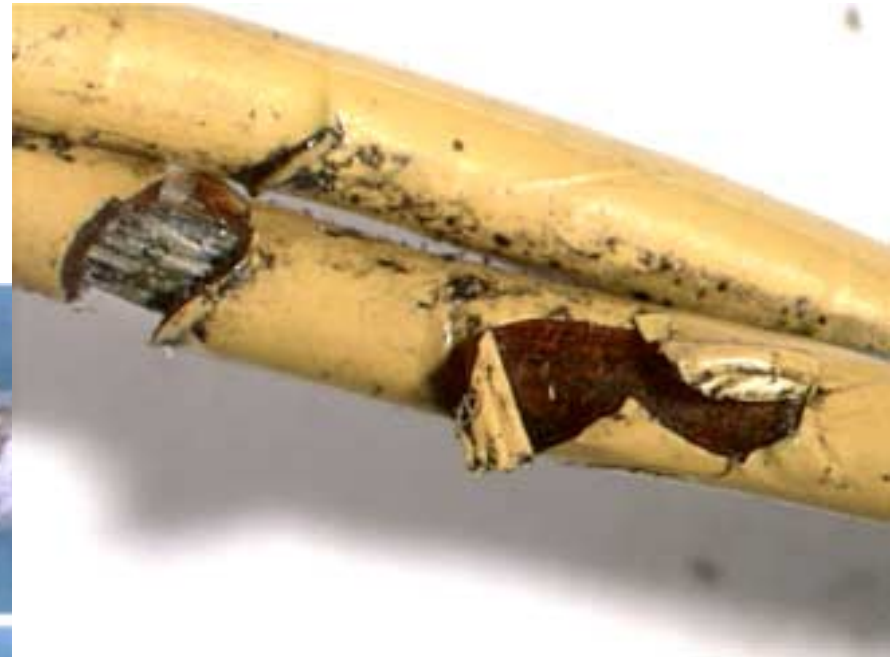
# Polyimide

- **Polyimide:** Instance of delamination were observed on the A300 and L1011.
- **PVC/Glass/Nylon:** Substantial degradation of wire on one the two DC-9 aircraft (cracking, thermal degradation).
- **Poly-X:** Characteristic radial cracking.

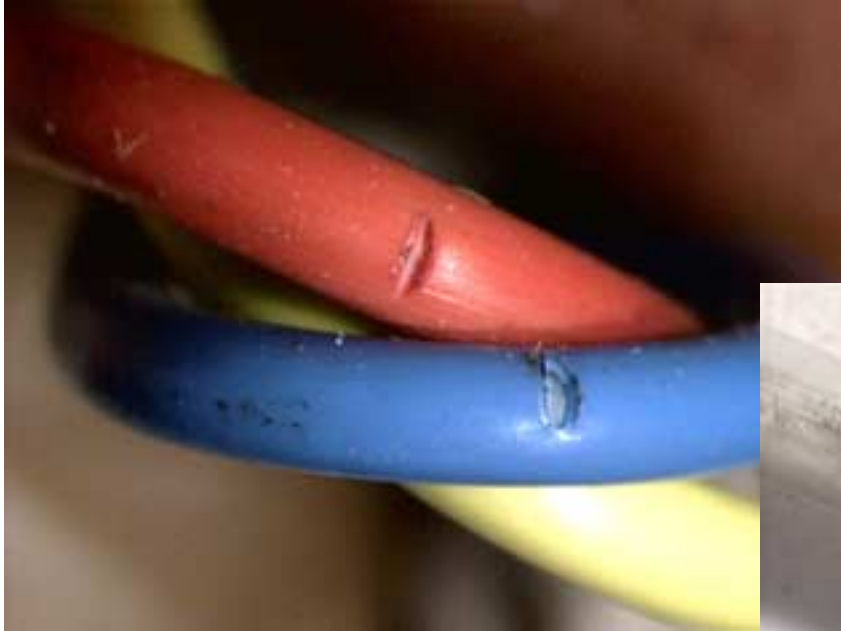
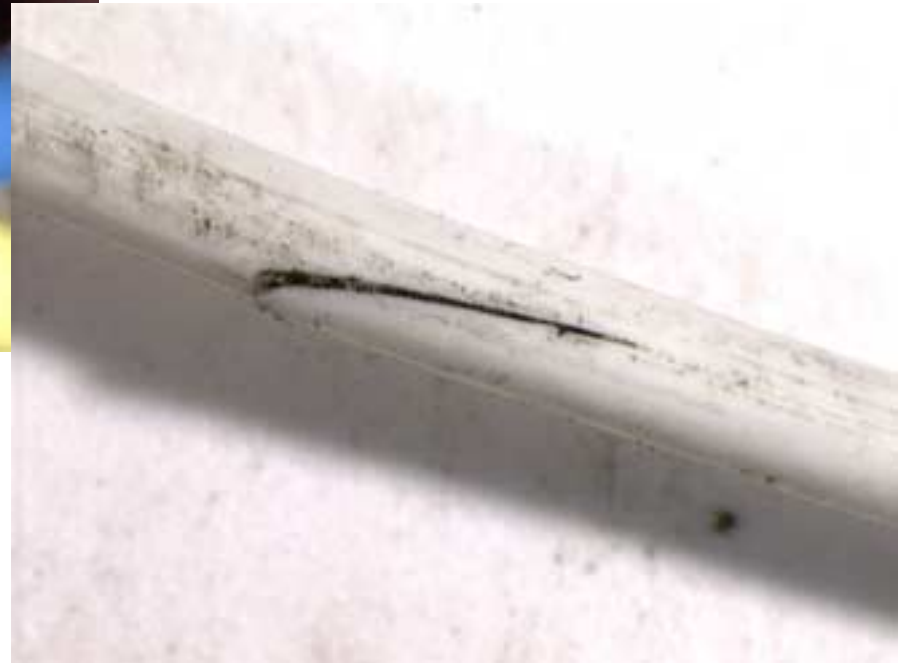
# XL ETFE

Note: this characteristic damage is not aged-related (degradation).

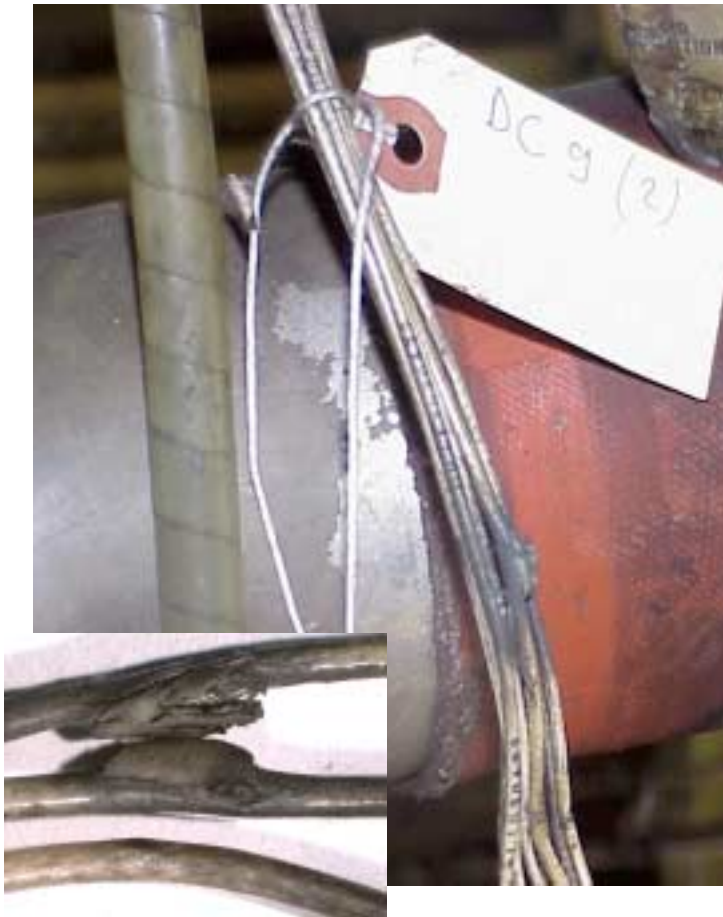
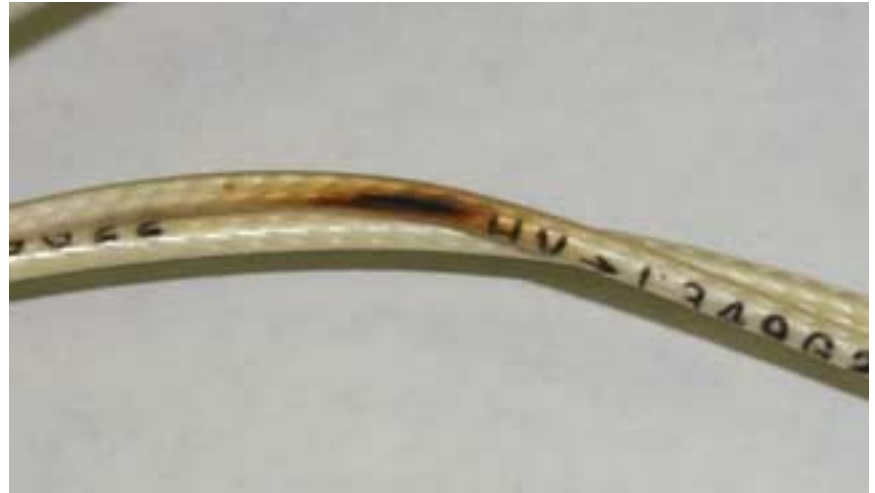
# Burnt or Heat Damaged Wire

Though the pictures show instances of burnt and heat damaged wire not visually detectable (because of spiral wrap in one case and the small size the damage in the other), this class of flaws is very often visually detectable.

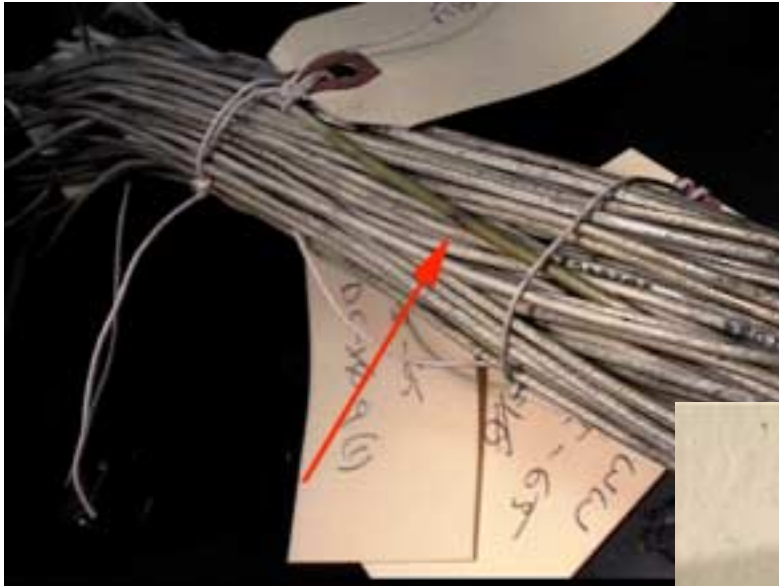
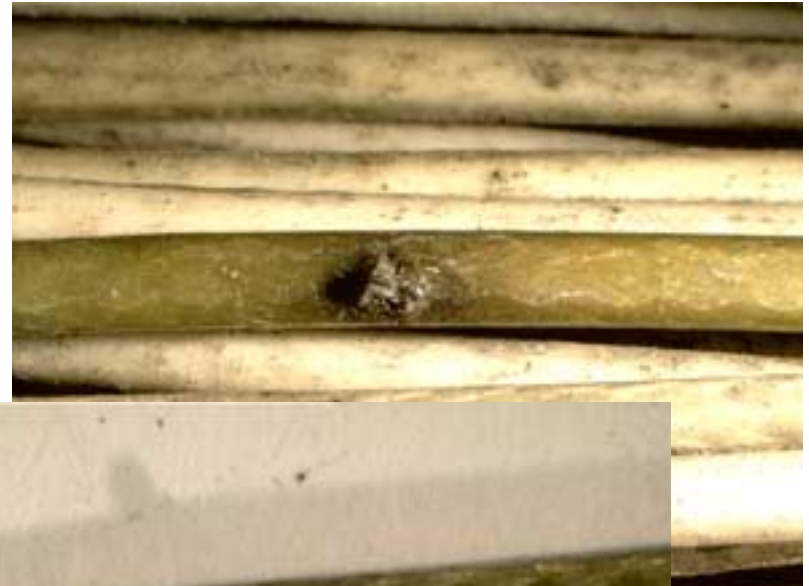
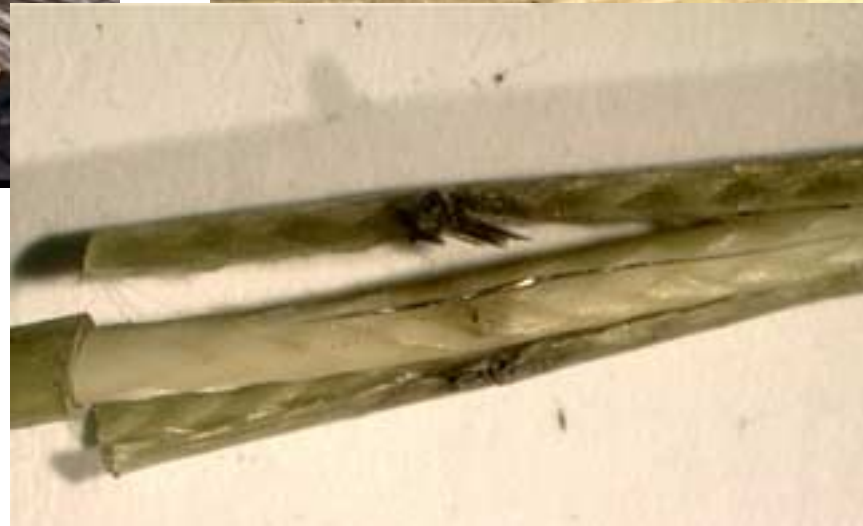
# Indirect Indicators

Obvious Discoloration of this single wire is associated with a flaw not visible to the naked eye.

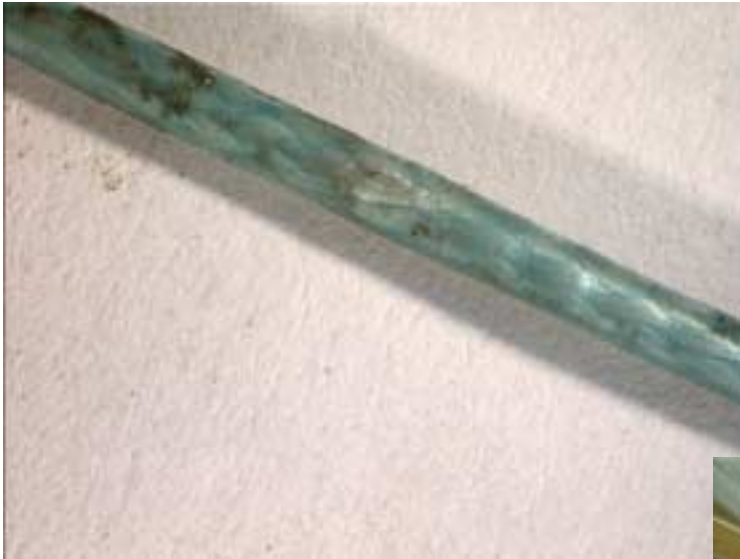
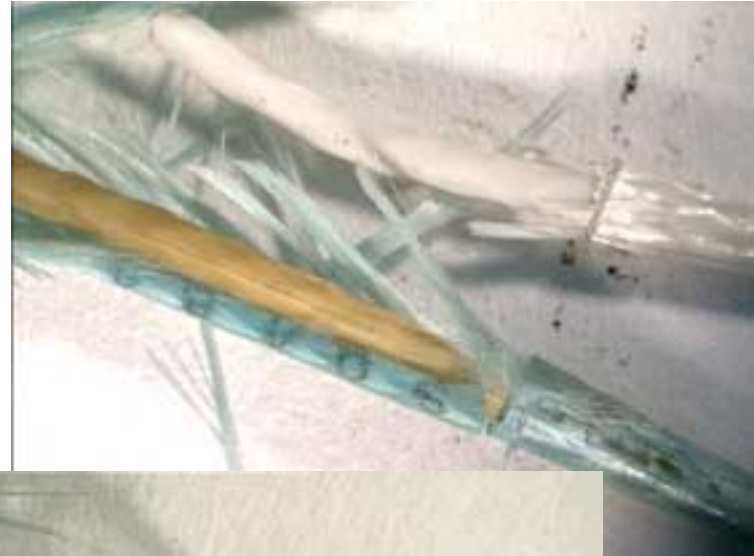
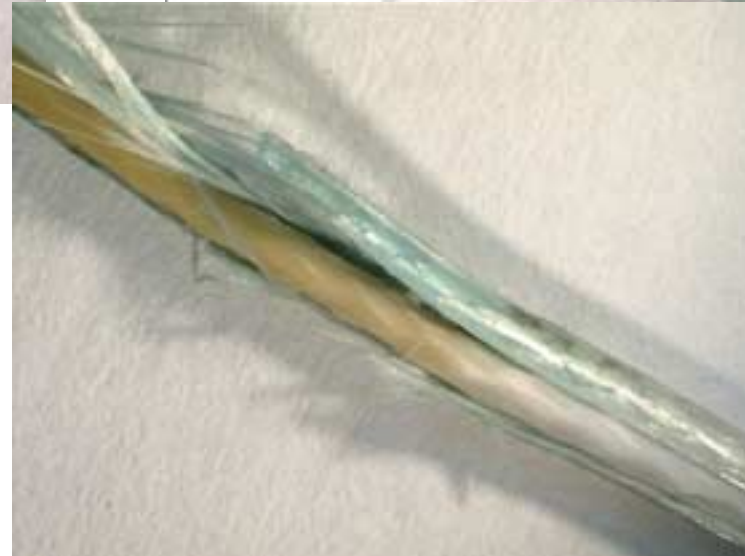
# Blue Water Contamination

The blue discoloration of the nylon and glass outer layers is exactly coincident with the yellowed (and presumably degraded) PVC insulating layer

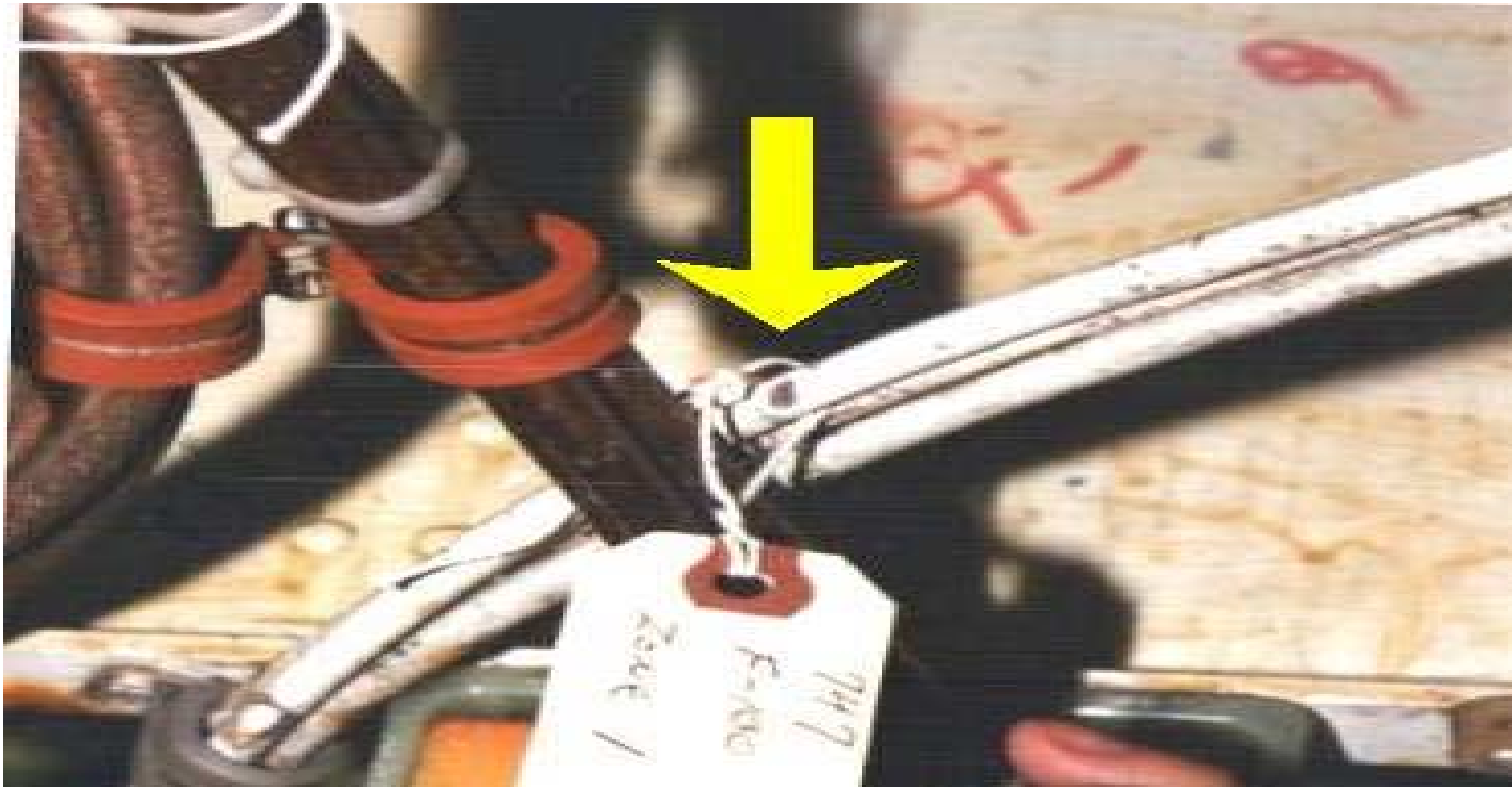
# Chaffing

This is an instance of generator feeder cables chafing against XL-ETFE power feeder cables. Though the chafed area is not visible the inappropriately routed and crossed wires are. The data indicates that chafing is often visually detectable.

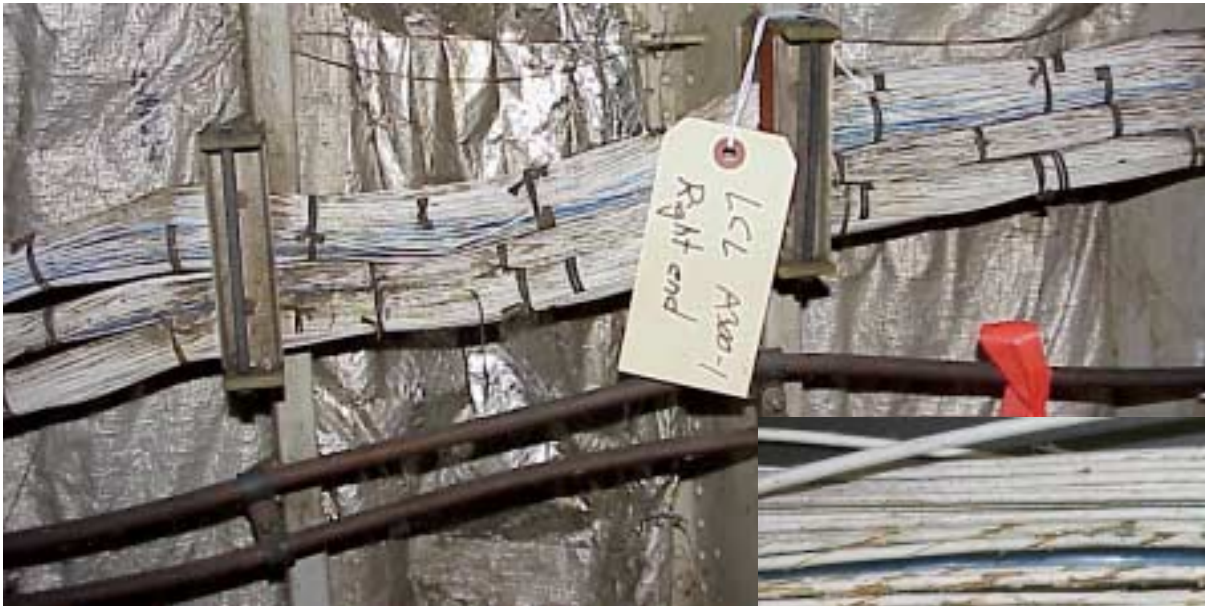
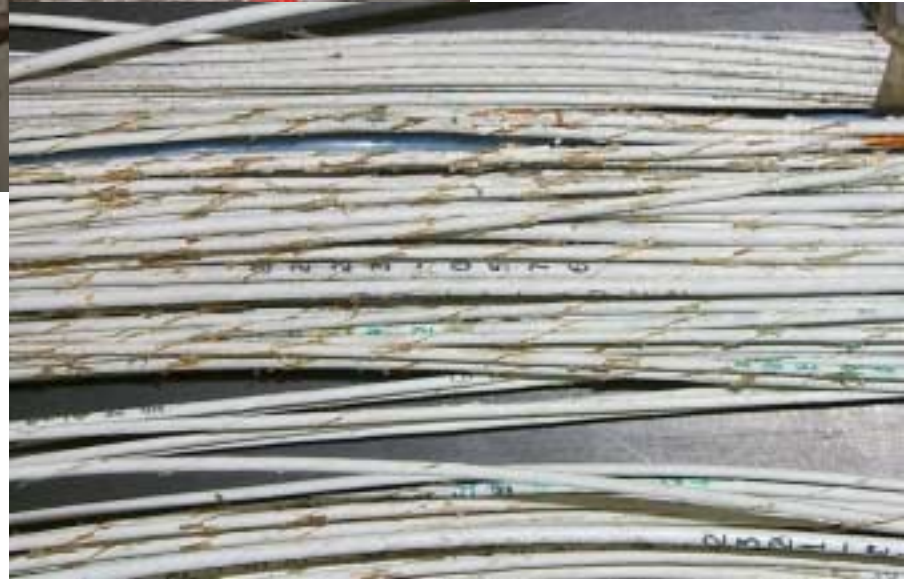
# Delamination

While intuitively it may seem that delamination is visually detectable, it can occur inside a bundle. This delamination was not detected visually.

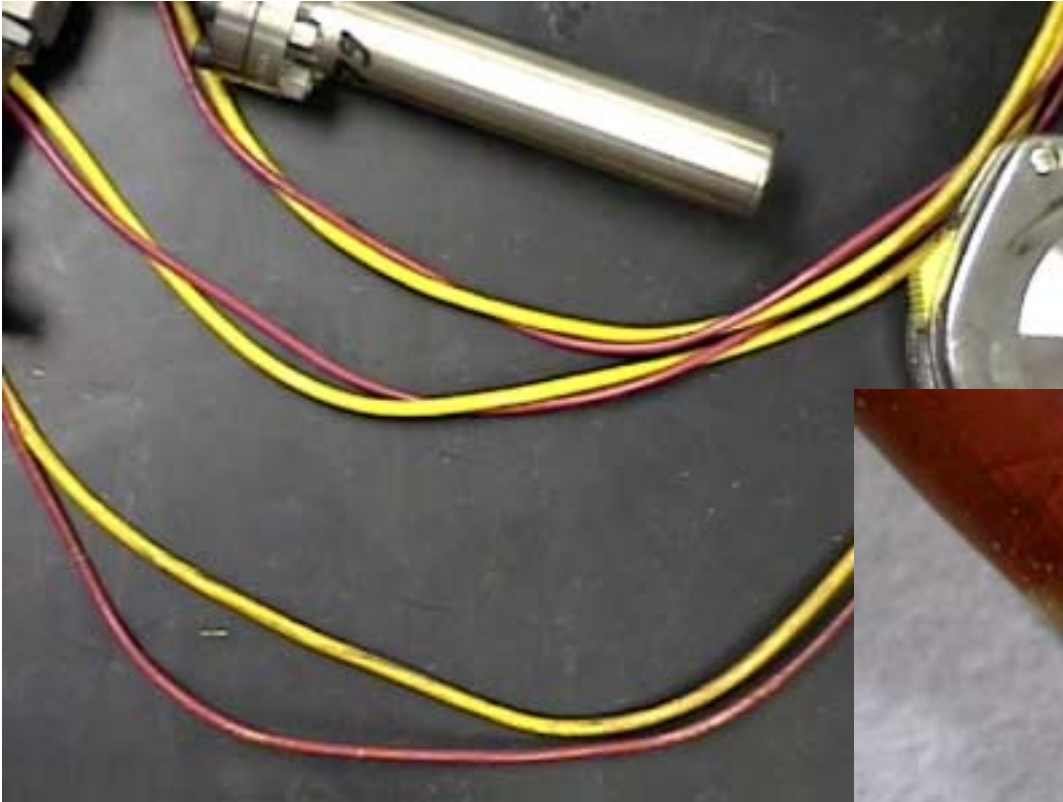
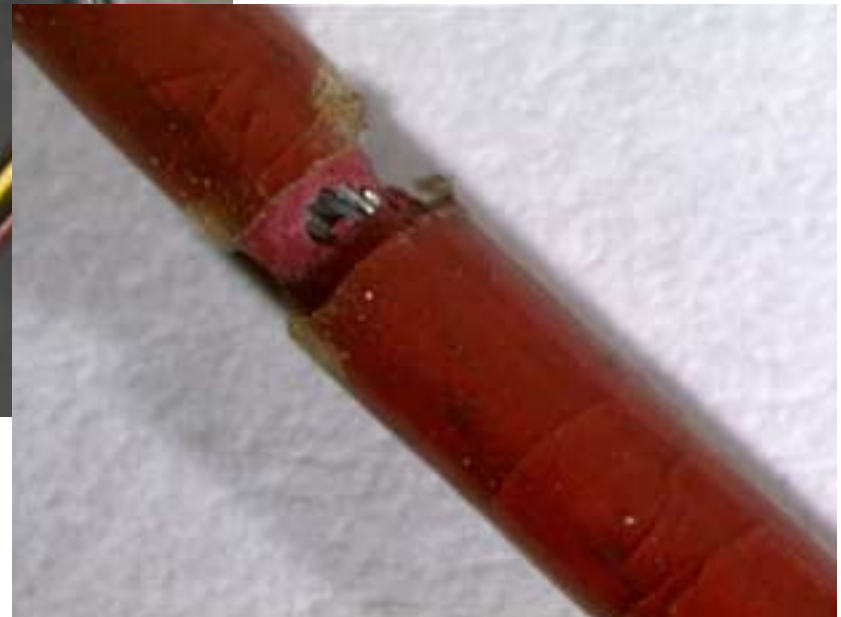
# Visually Detectable?

We cannot rely exclusively on visual inspection to detect cracked wire.

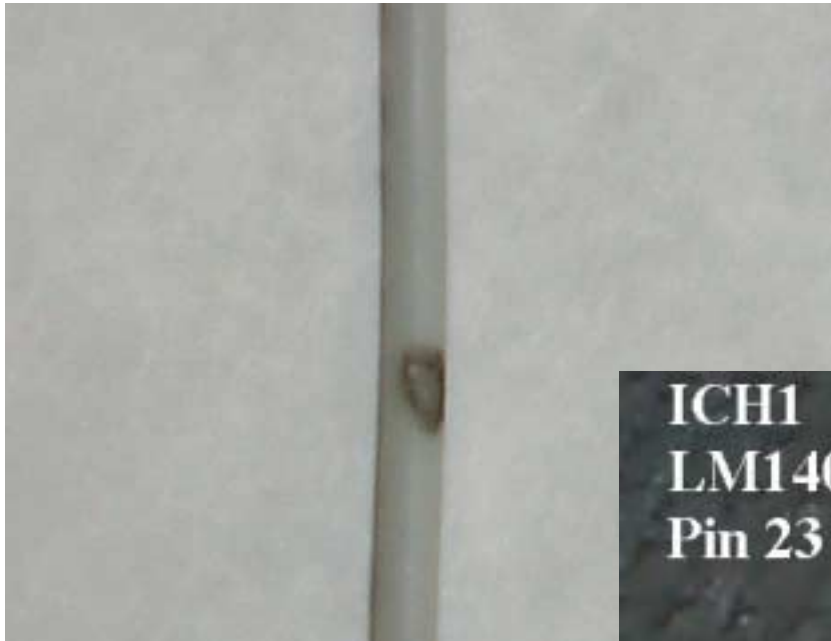
This localized burning damage on an otherwise unremarkable wire is evidence of electrical arcing

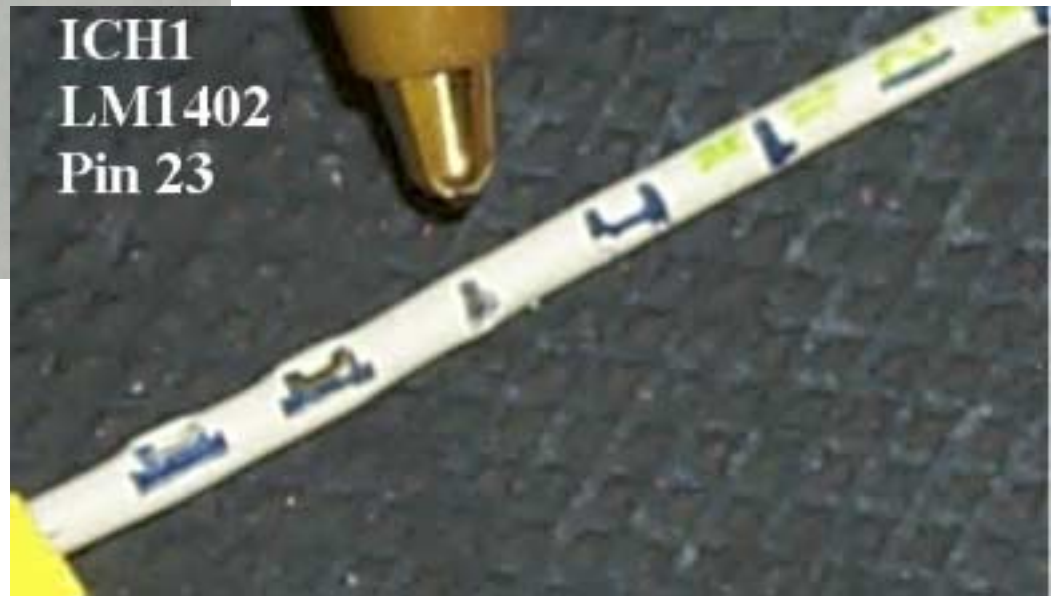
Insulation Breach at hotstamp

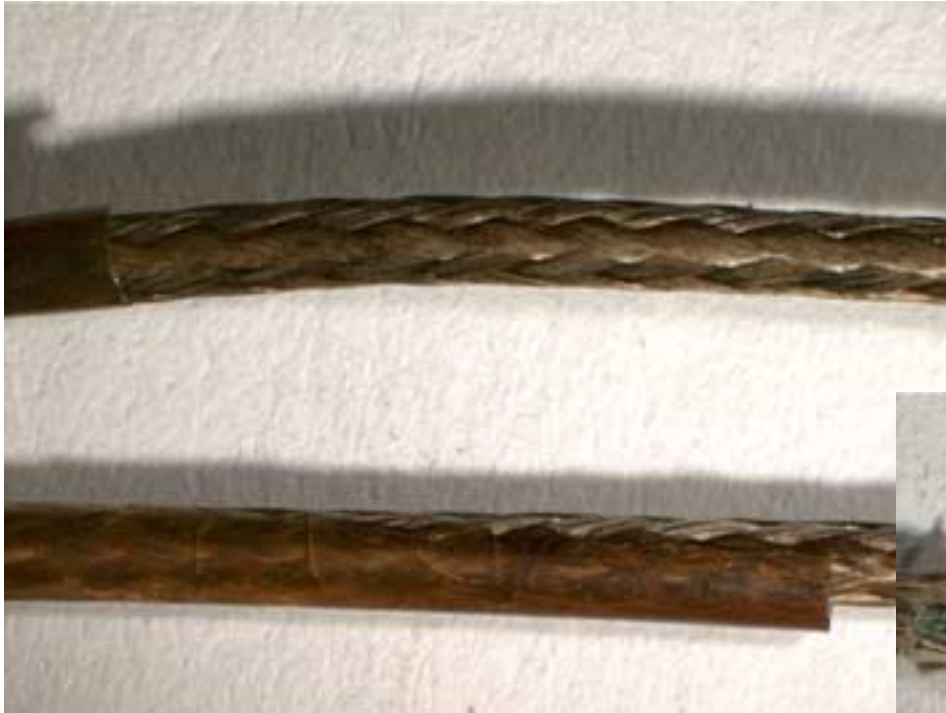
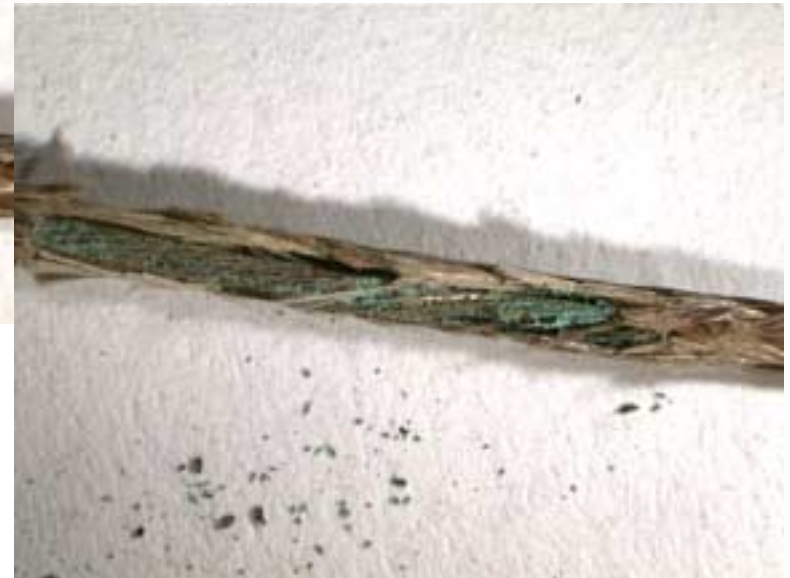
# Hidden Deterioration

Though this PVC/Glass/Nylon wire has obviously darkened over time, the full extent of damage is not revealed until the nylon and glass layers are removed.

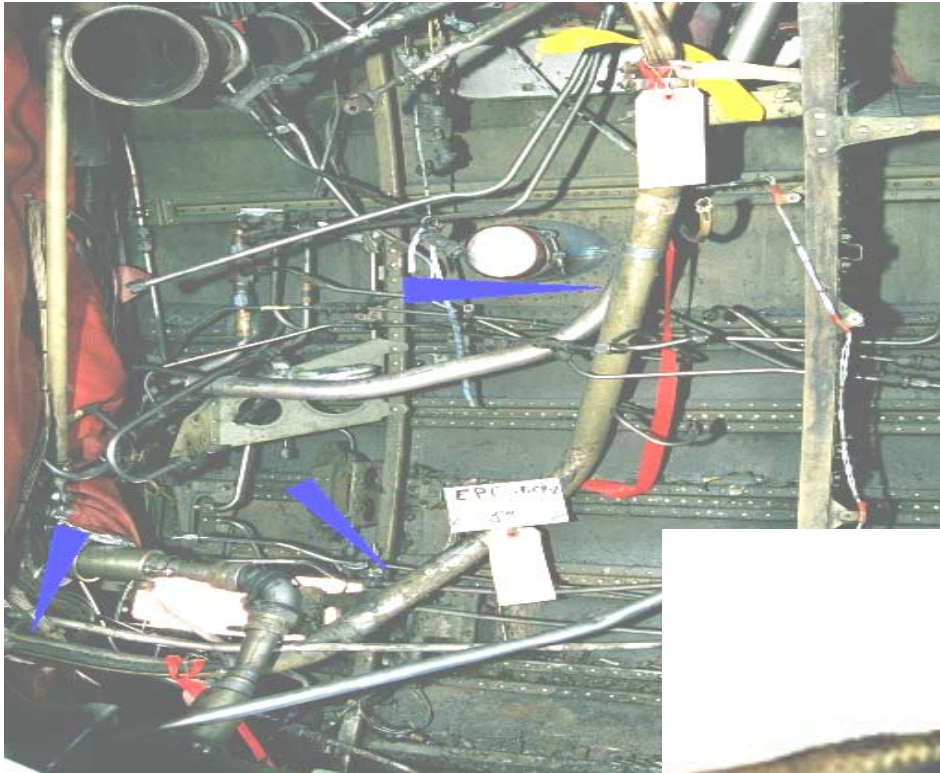
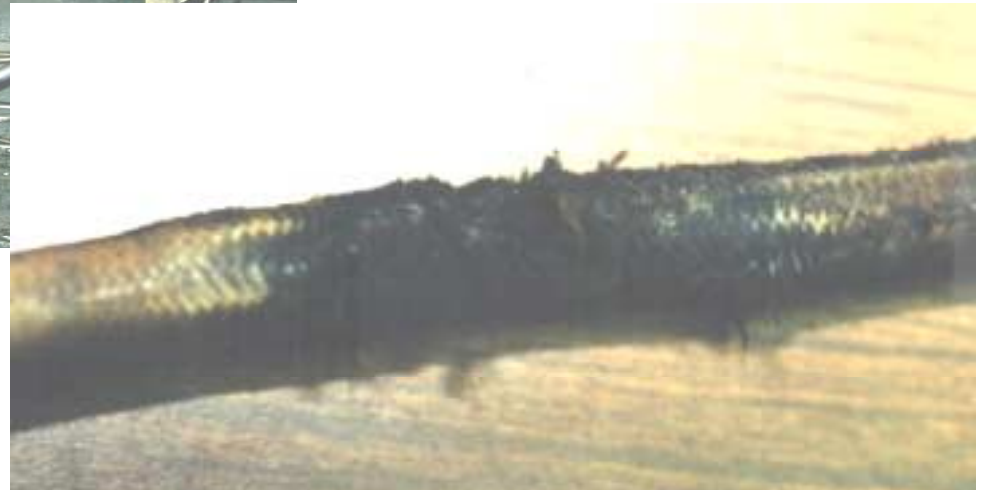
# Inaccessible Flaws

The metal conduit at left was supposedly protecting the breached wire shown below.

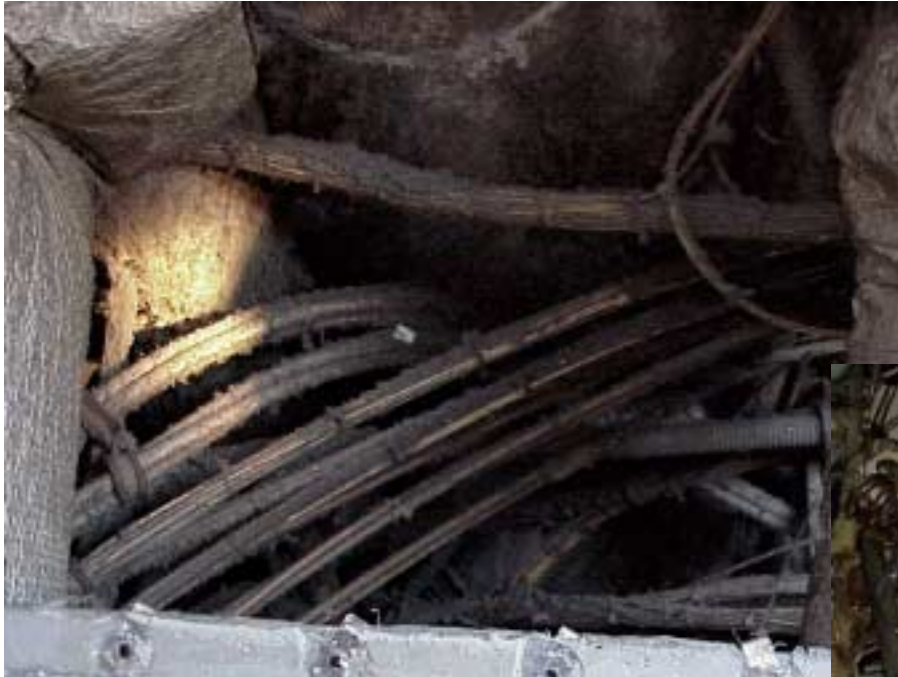
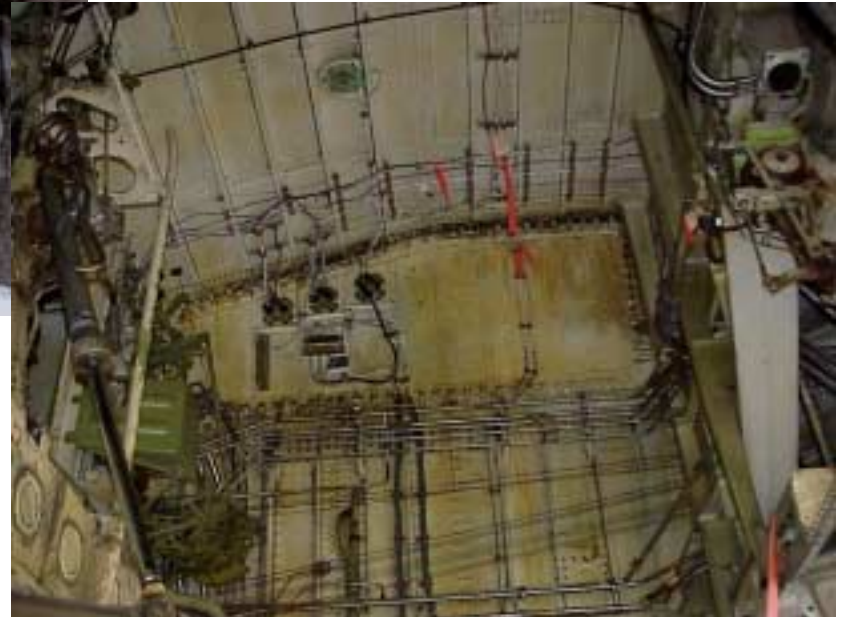
## Contamination

Solid and fluid contamination can increase both the risk of electrical failure (by providing alternative conductive paths) and the potential for fire (by providing fuel).

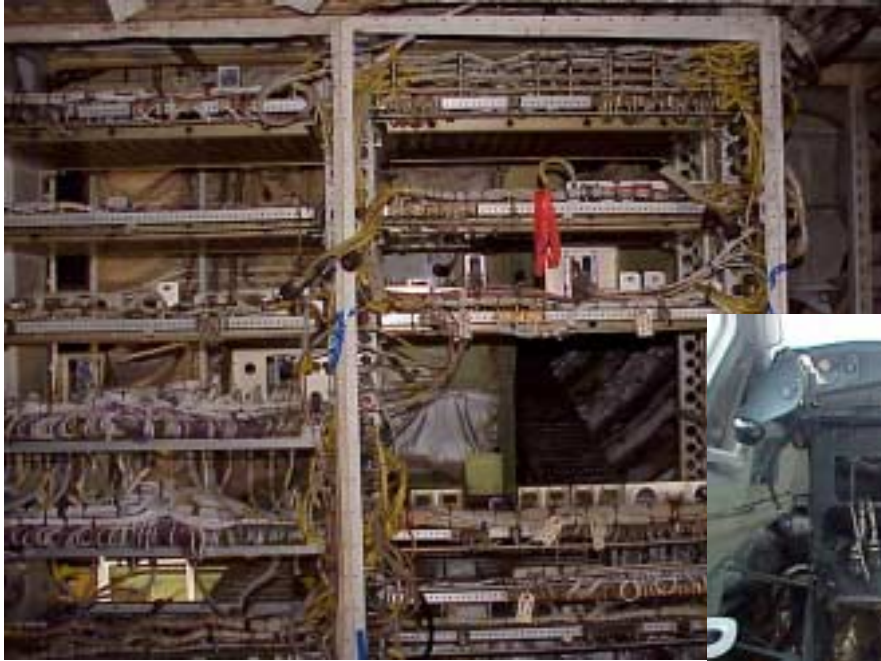
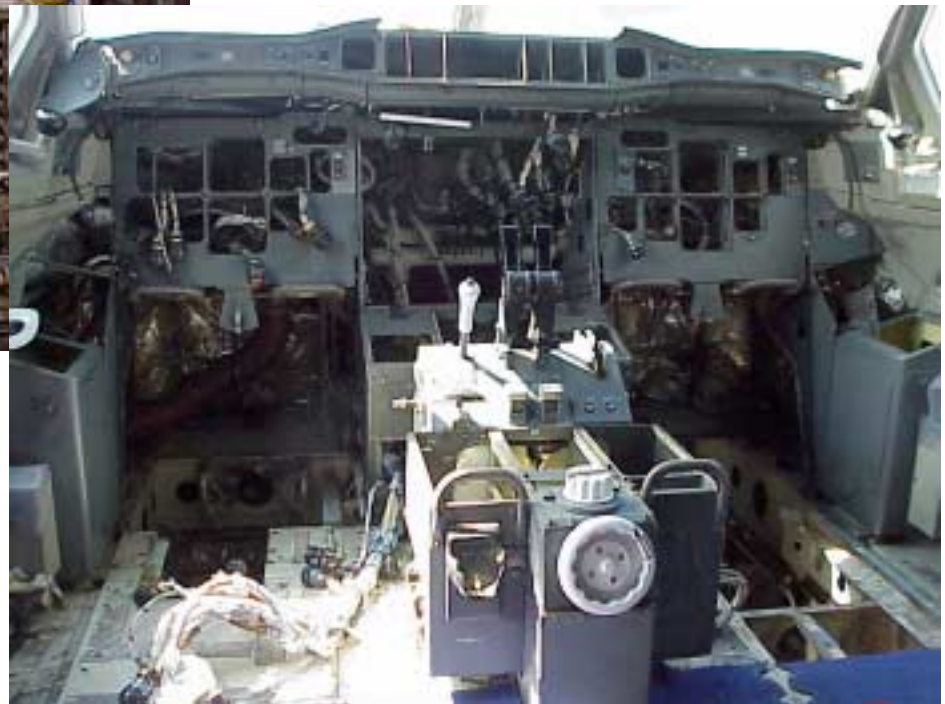
## Electronics Bay and Cockpit

The abundance of wire in these zones as well as the importance of the systems they support demand that the cockpit and electronic bay receive special attention.
