Managing Electrical Connections Systems and Wire Integrity on Legacy Aerospace Vehicles

Steven Sullivan
Kennedy Space Center
NASA
and
George Slenski
Materials Directorate
Air Force Research Laboratory

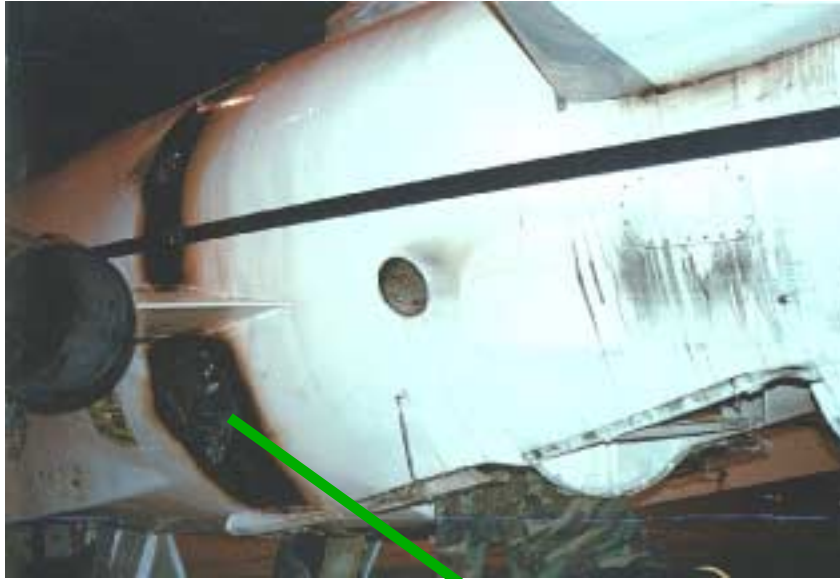
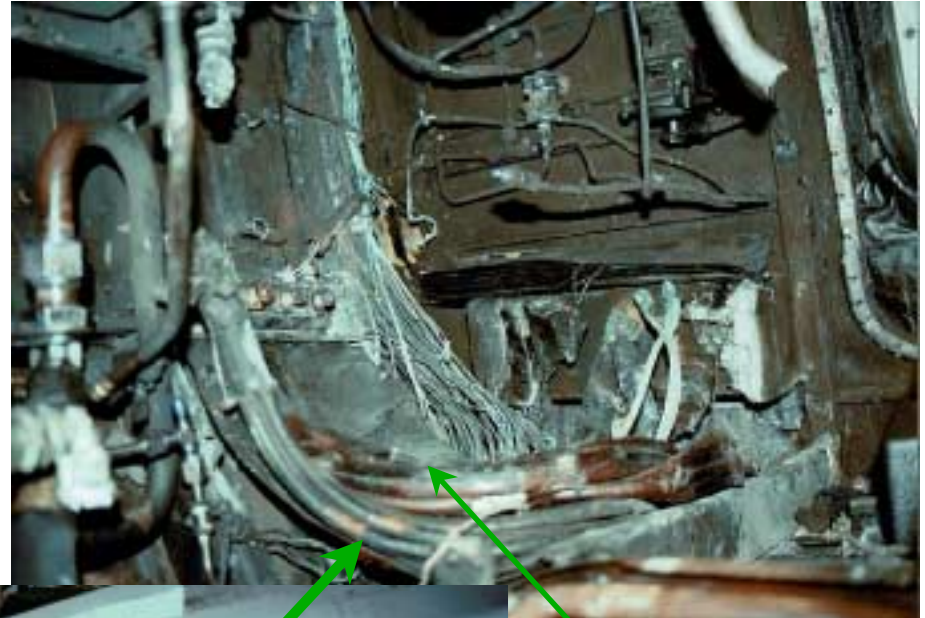
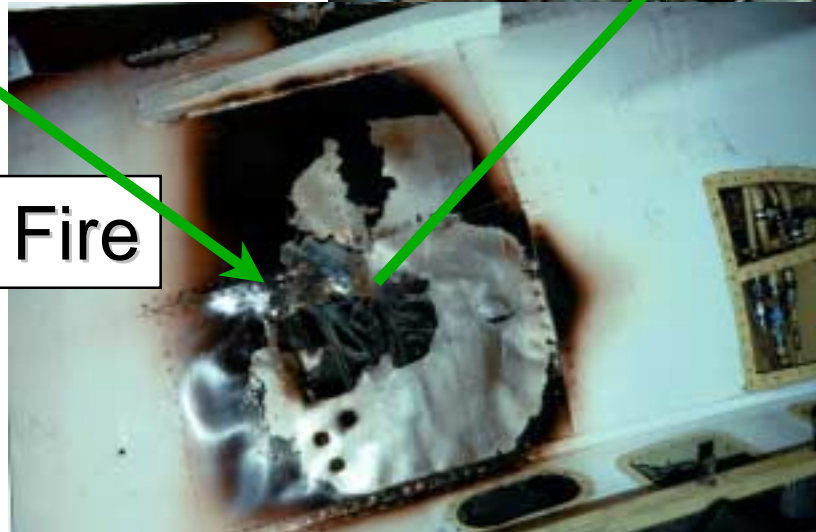
Wiring System Failures

In-Flight Electrical Fire

Initiation Site

Chafed Wire Failure

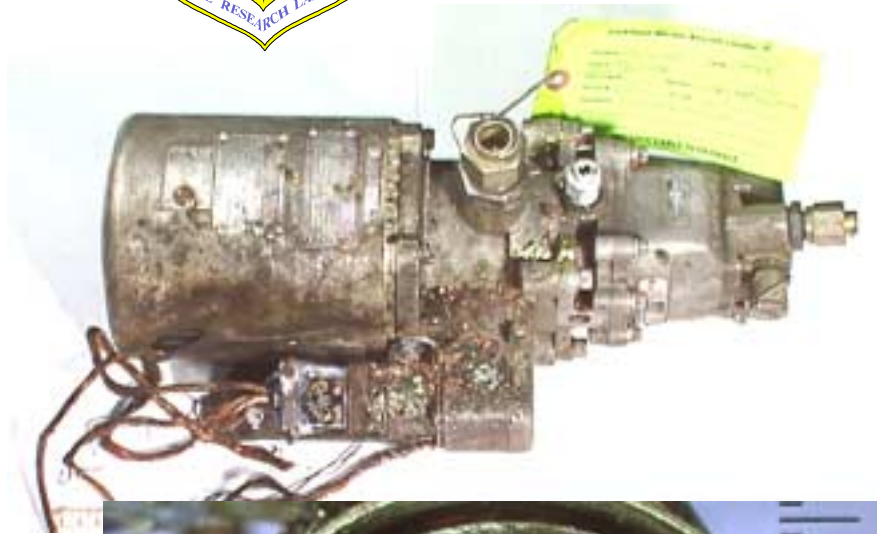
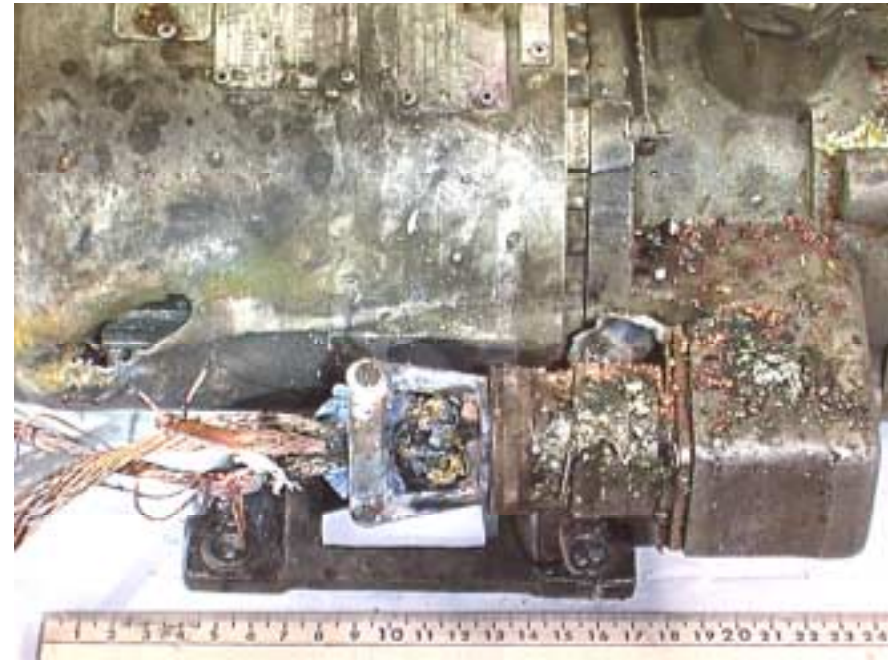
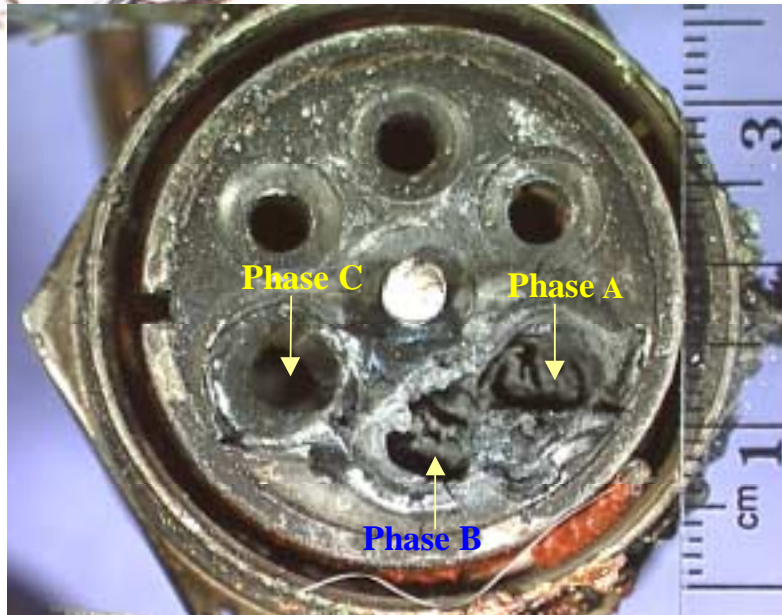
Failure Initiated by Degraded Bearings and Wire Chafing

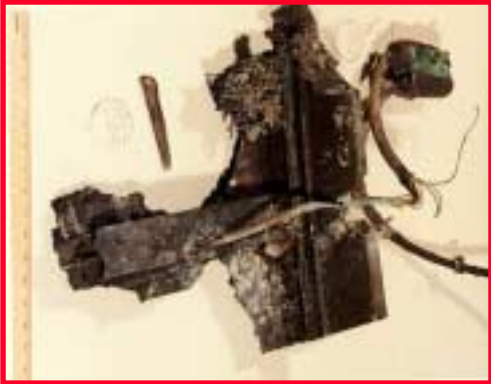
Electrical

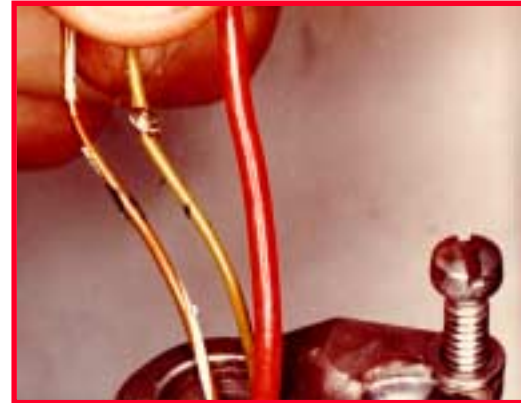
Mechanical

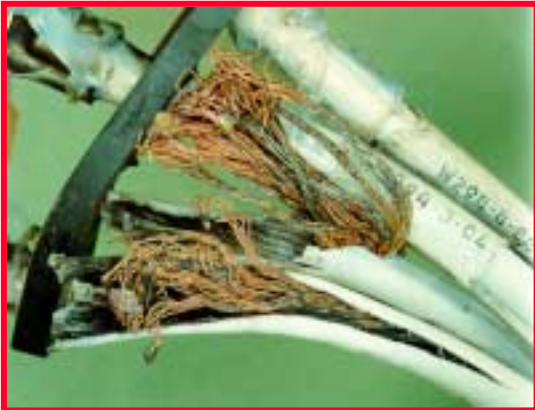
Thermal

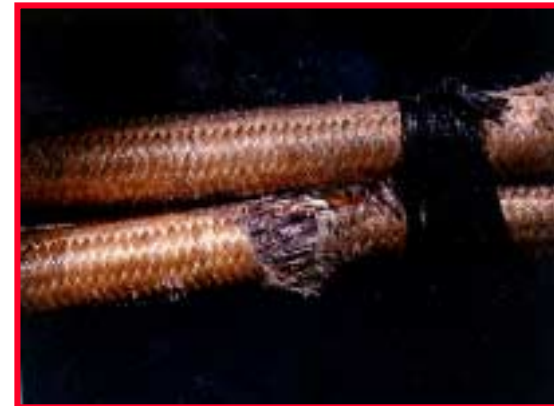
Chemical

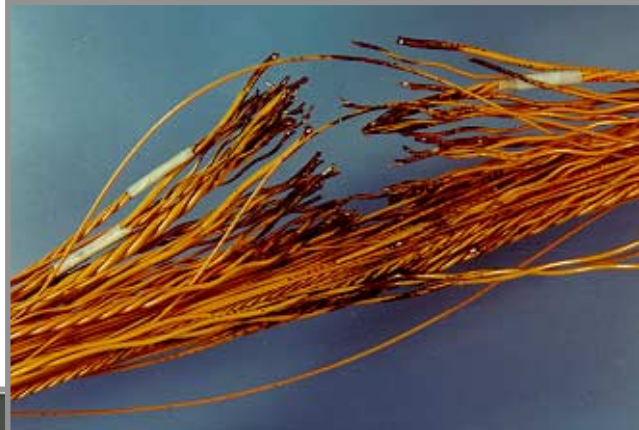
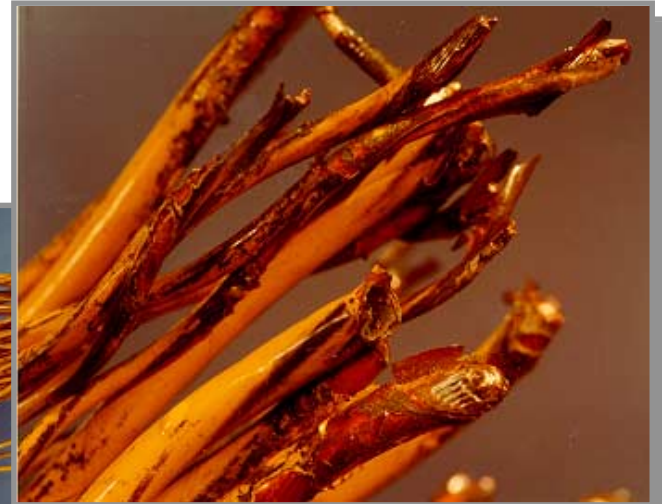
Arc Tracking Wire Failures

Field Failure

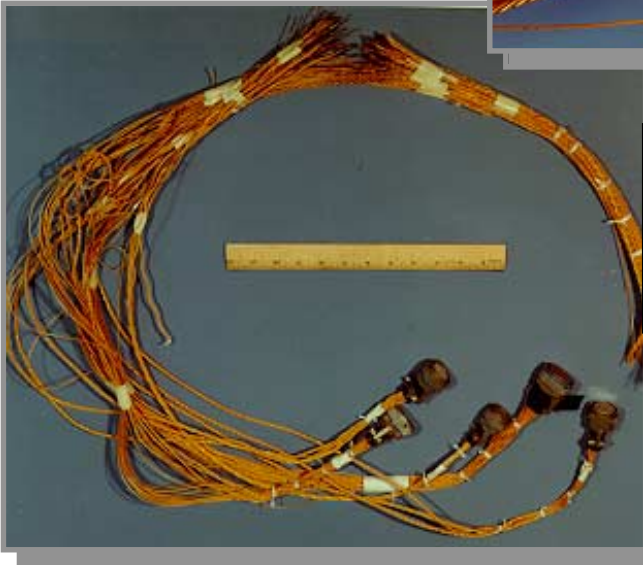
Dry Arc Tracking

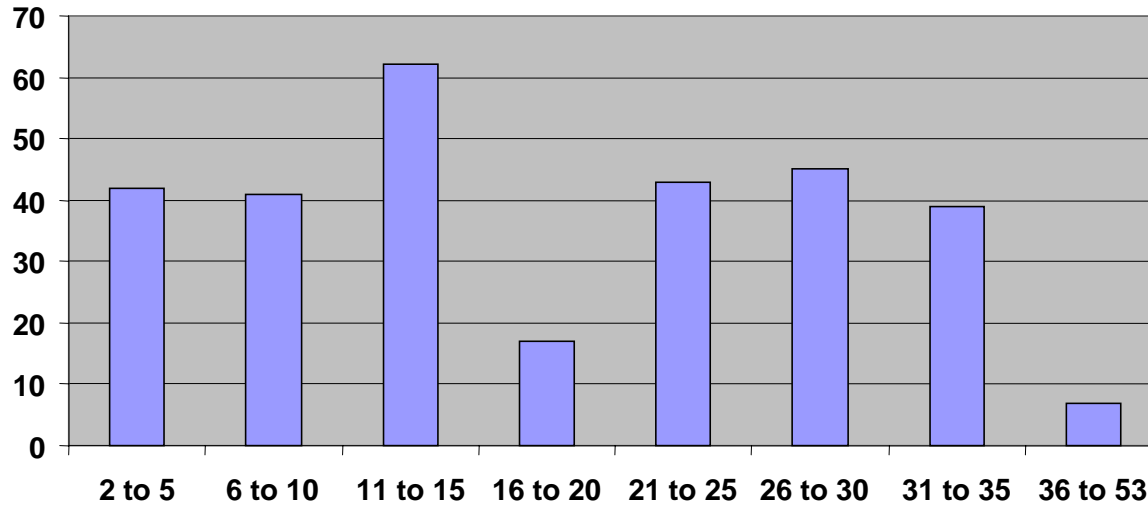
AF Mishap Data For Electronic Related Failures

Age Groups of Mishap Aircraft

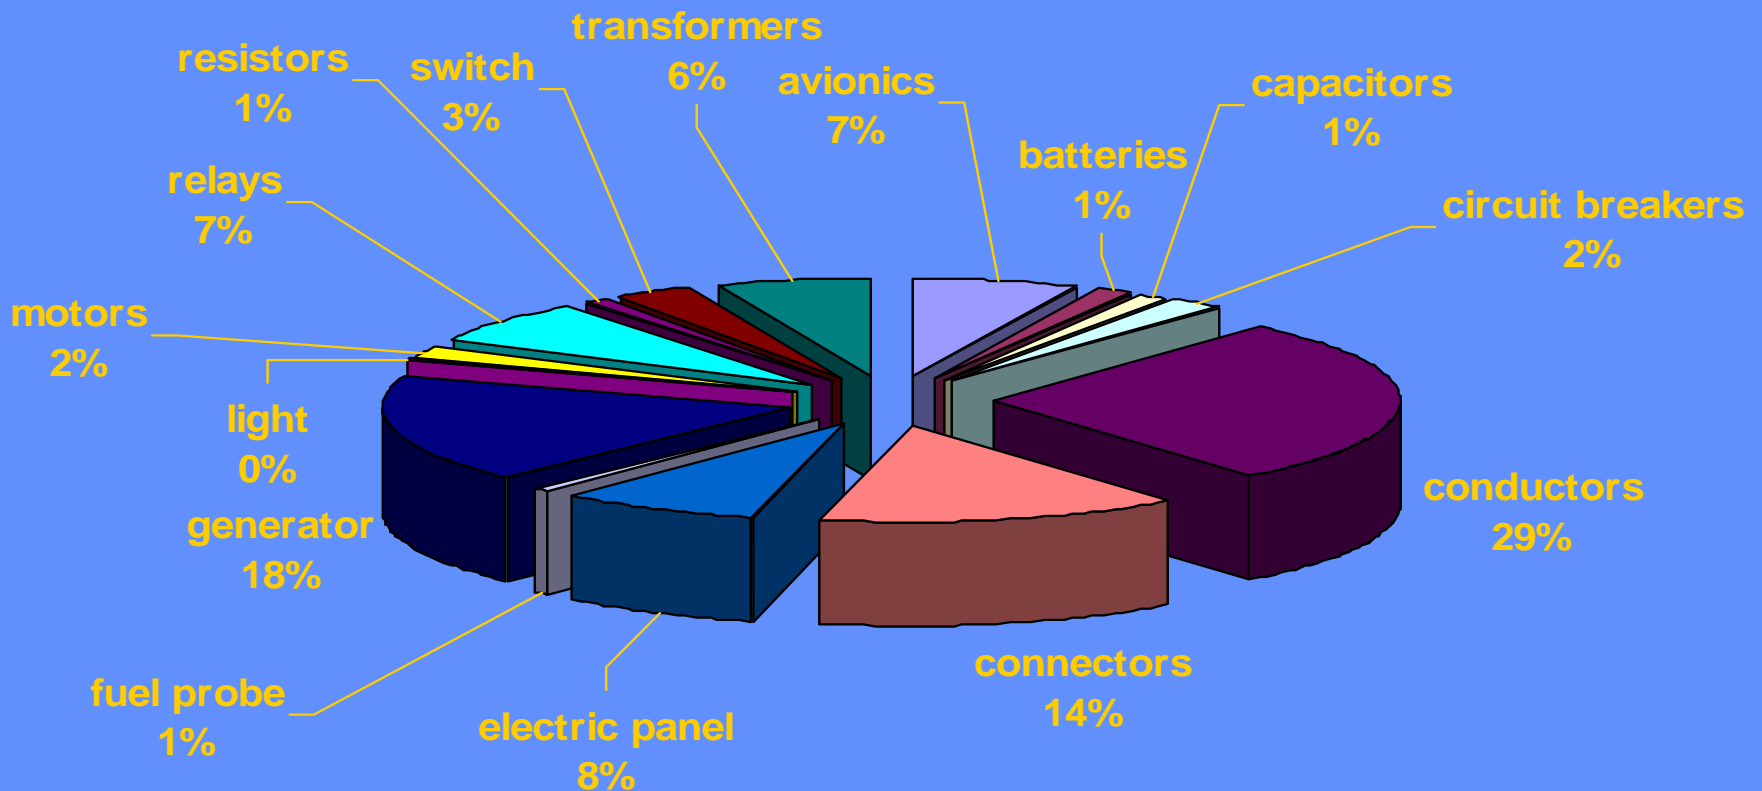
AF Mishap Data Related to Electronic Failures (1989-99)

Components Contributing to AF Mishaps

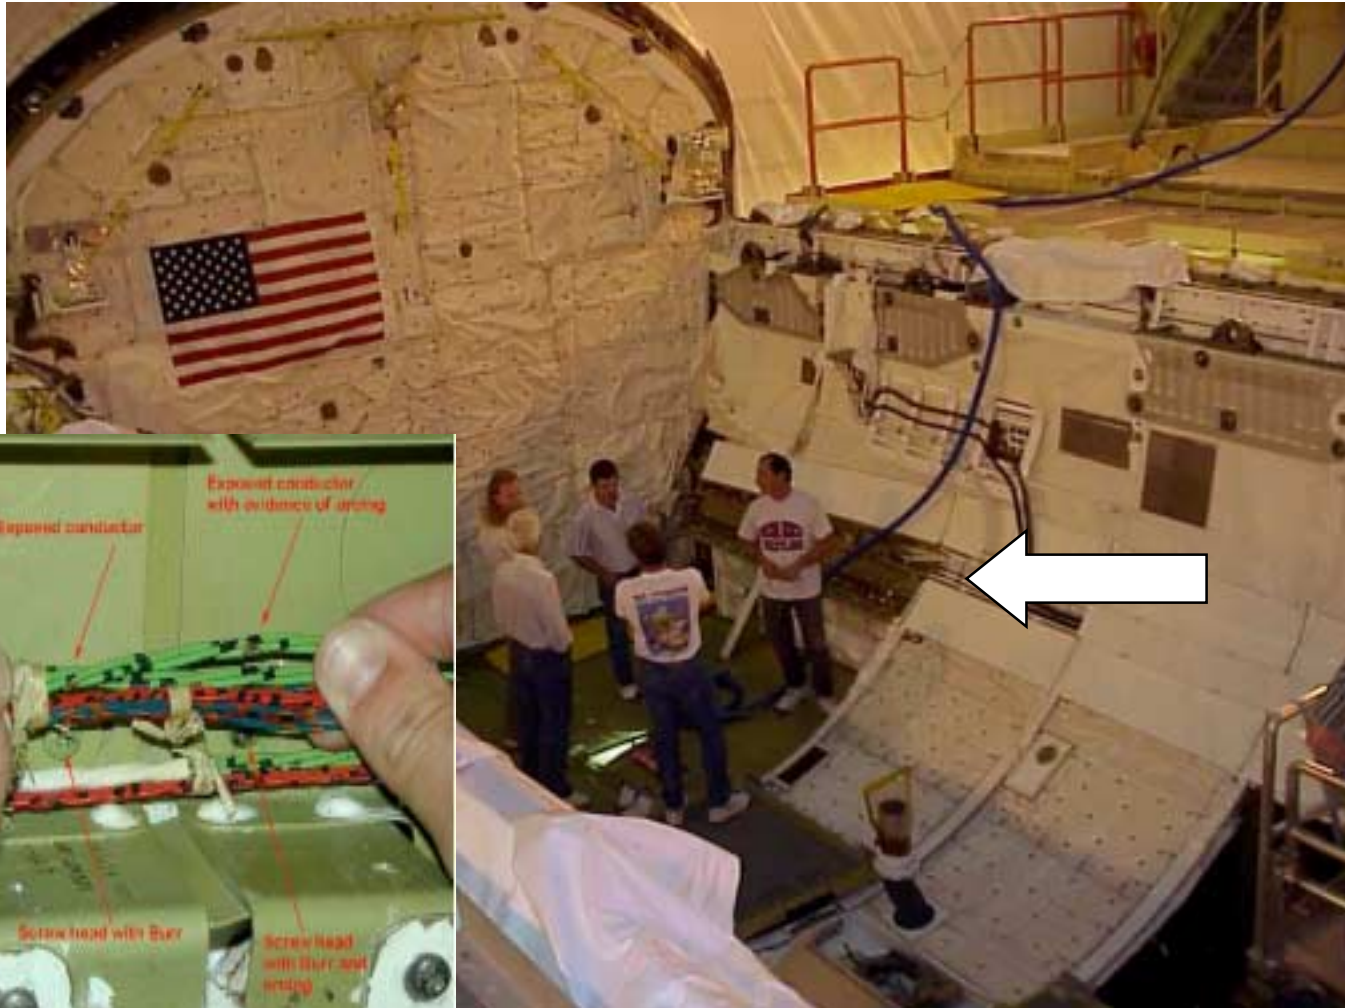
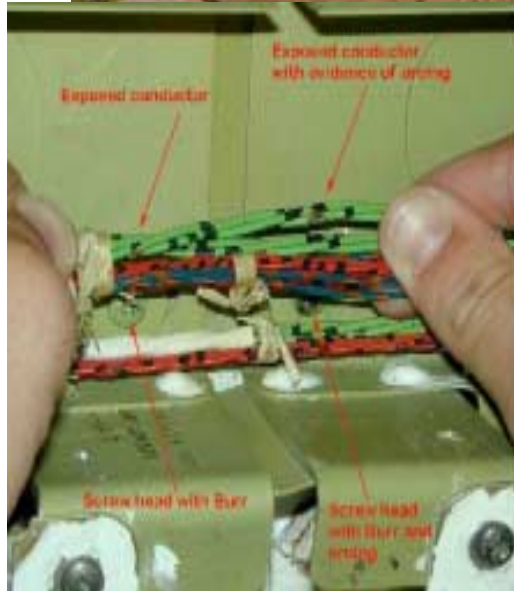
OV102 Electrical Short- Midbody

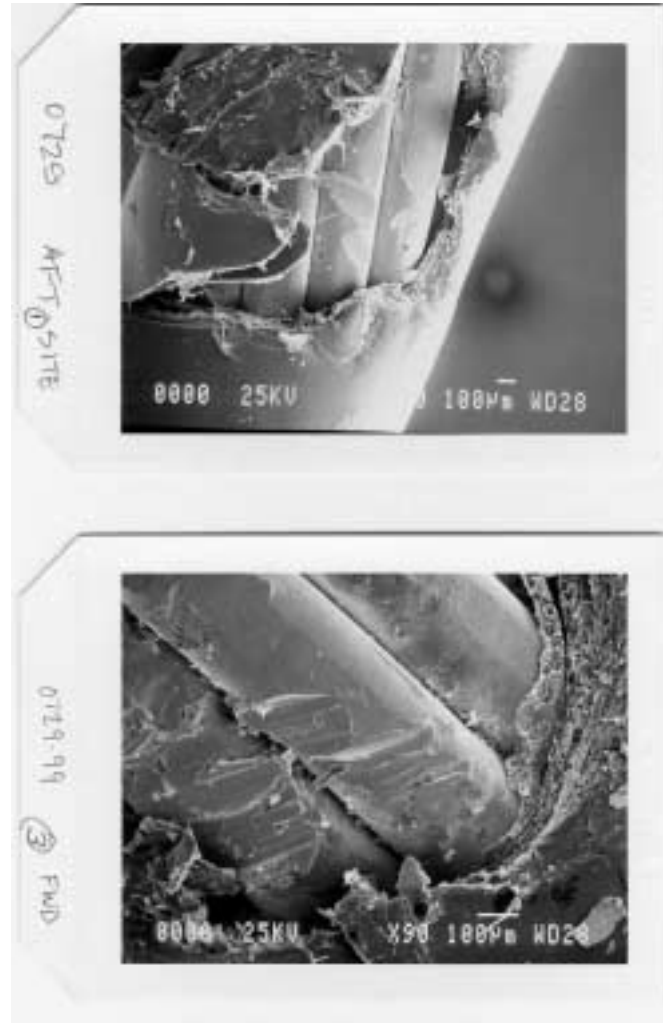
No evidence of vibration induced damage

(3 Independent Labs and AFRL Mal Lab)

Damage was caused by significant impact to cable

Oxide growth revealed that damaged wire had flown several times

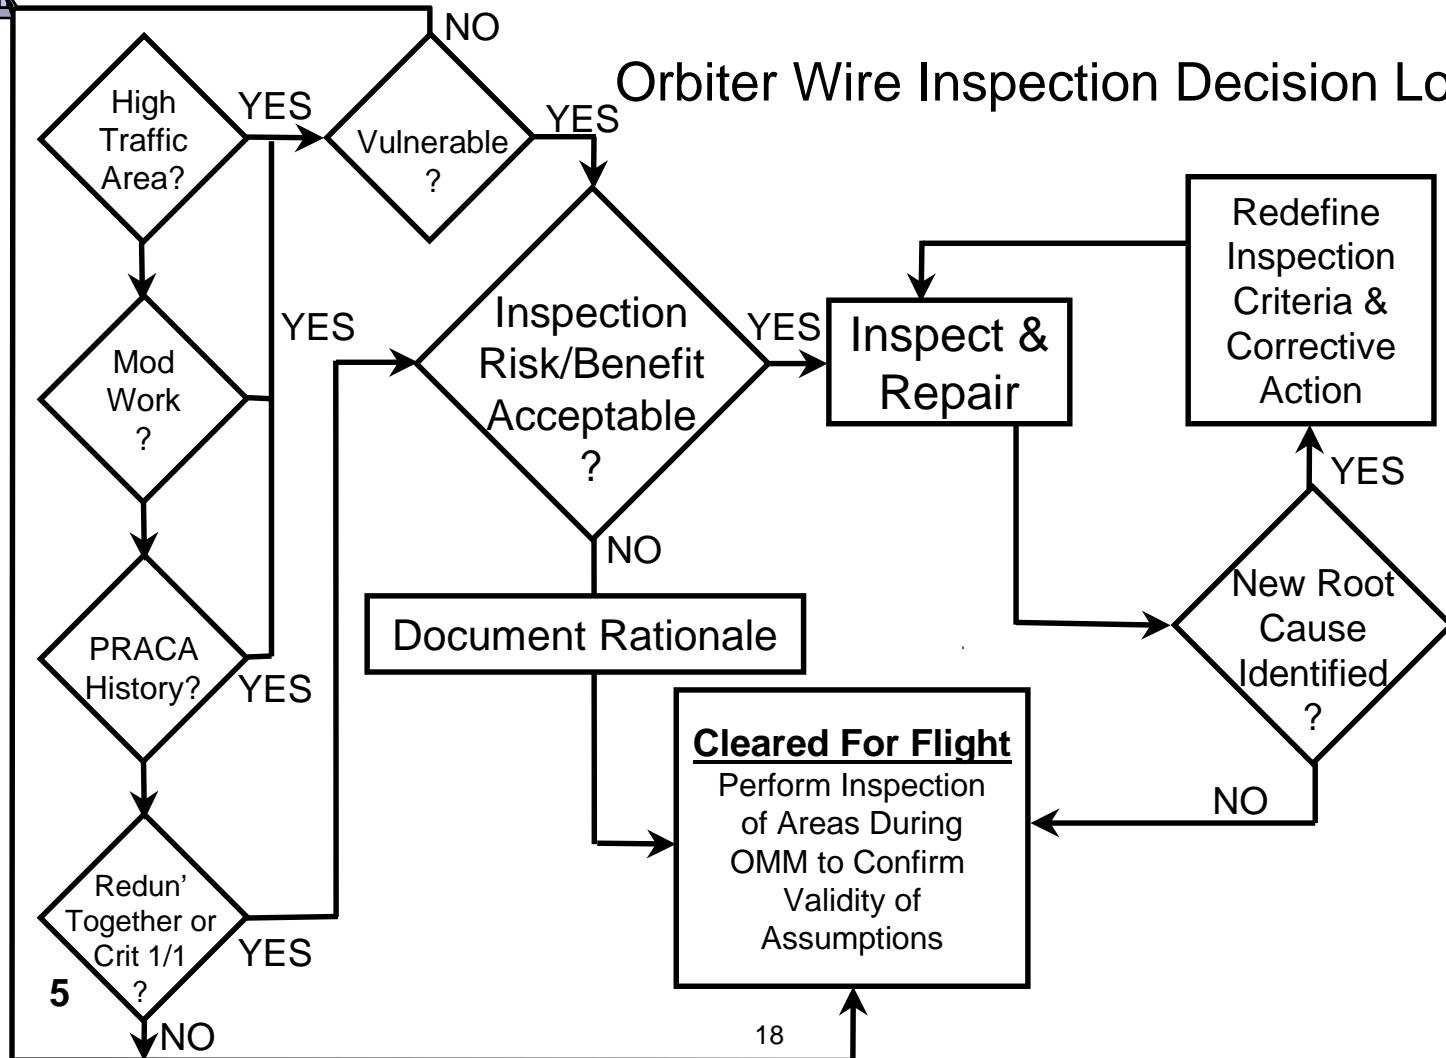
Orbiter Wire Inspection Decision Logic

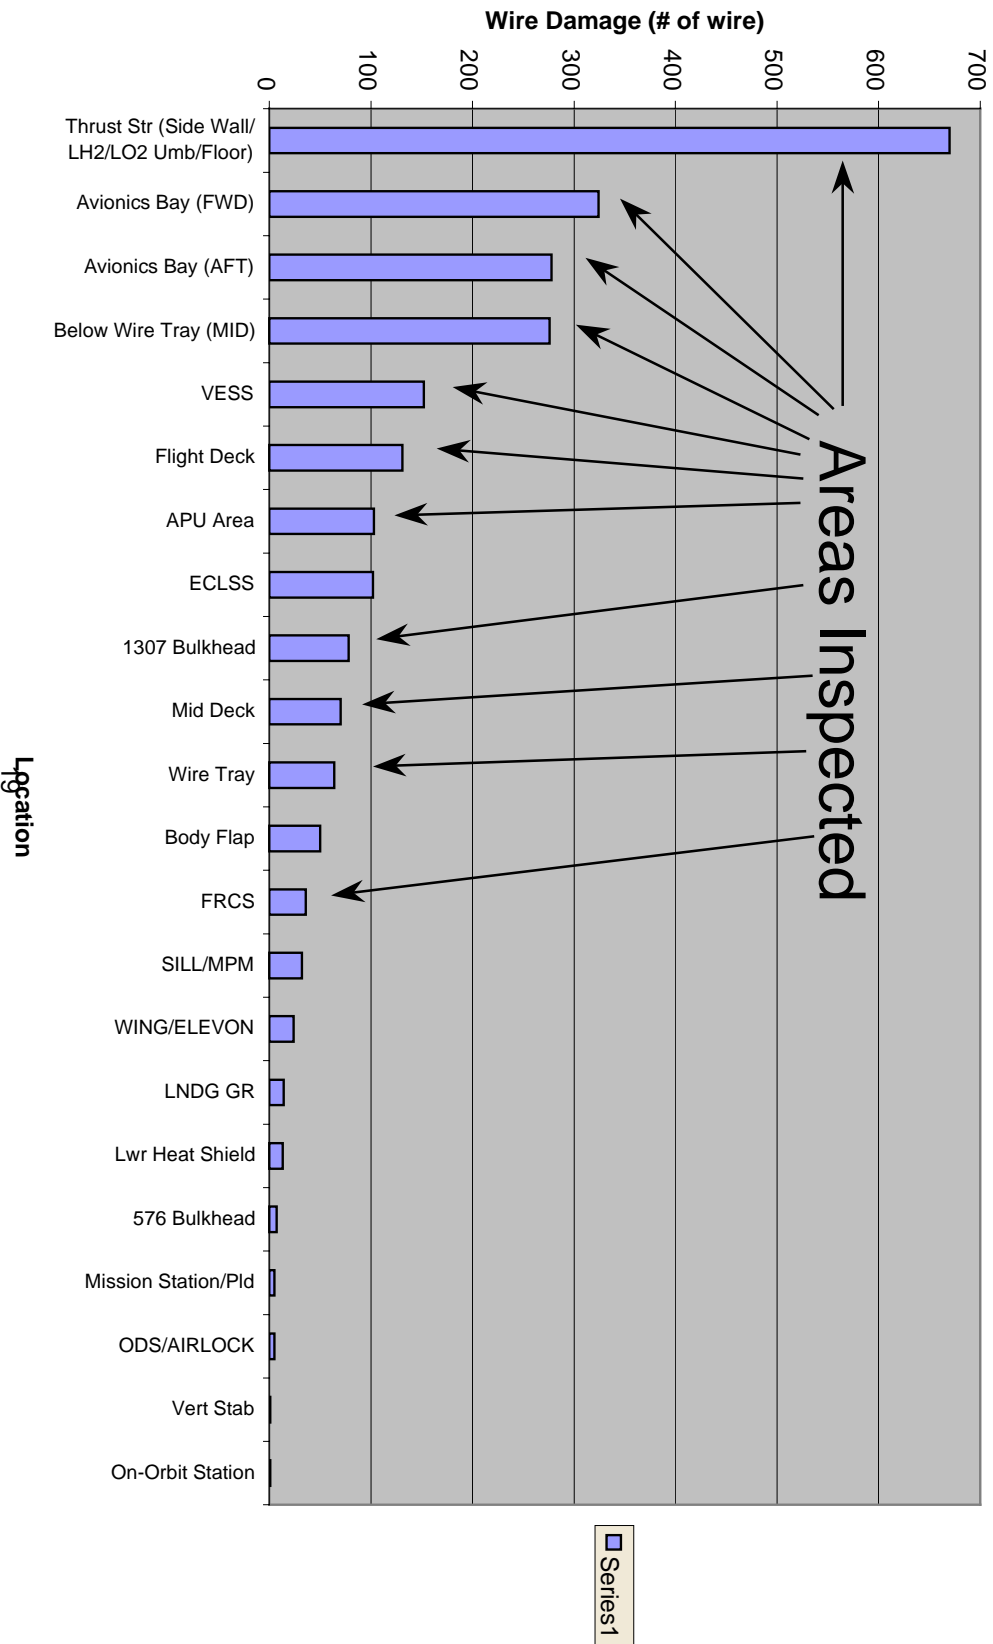
Analysis of Wiring Damage History

PRACA SUMMARY (FWD/MID/AFT)

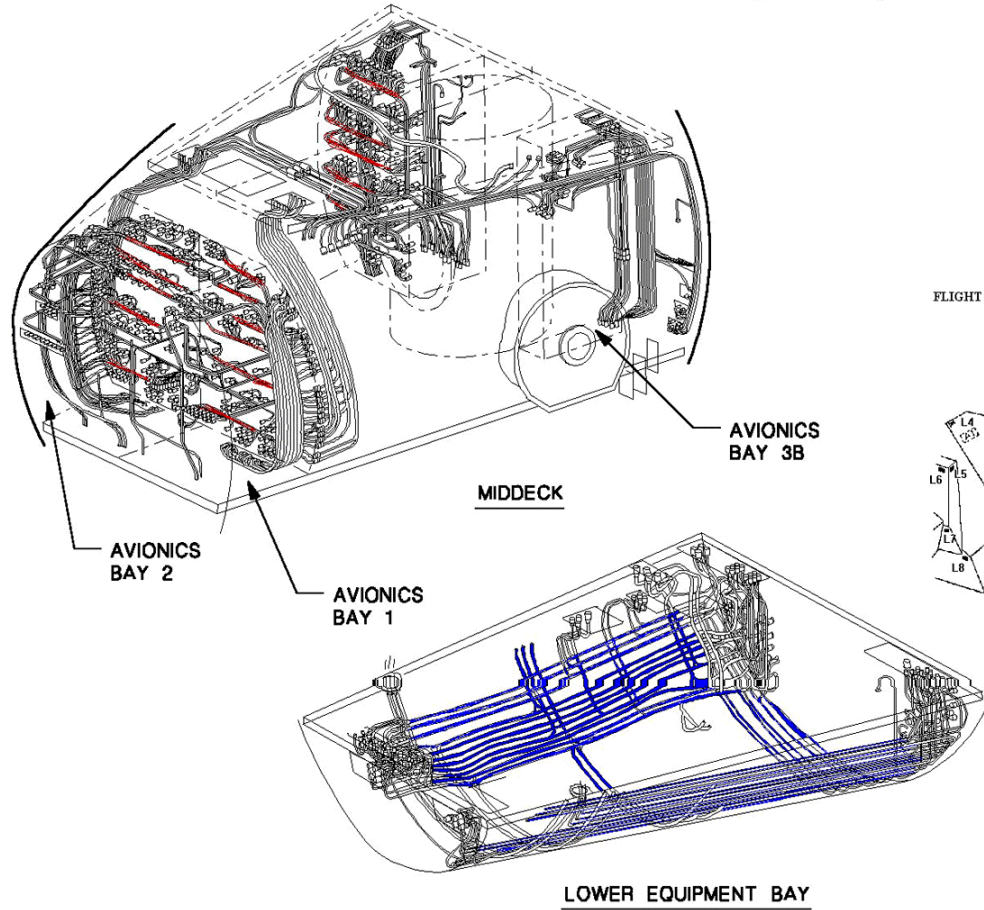
Summary of Inspected Wire Areas

- Inspected
- Convoluted Tubing

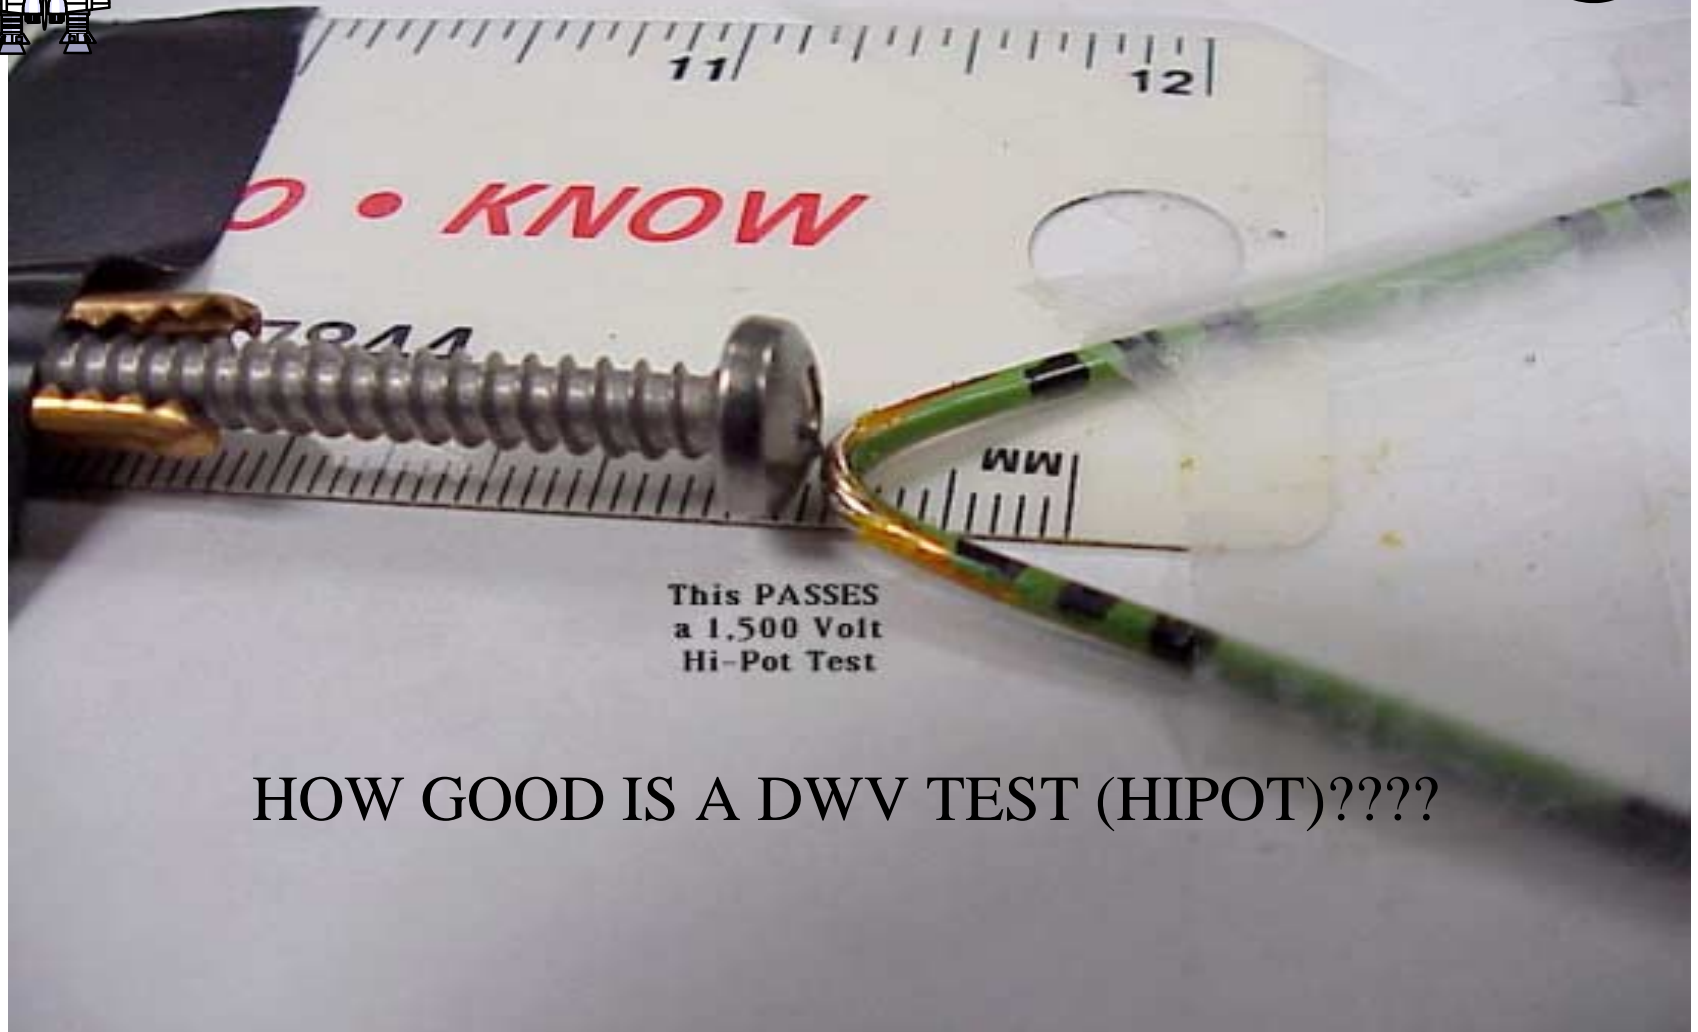
1500 VDC DWV Testing

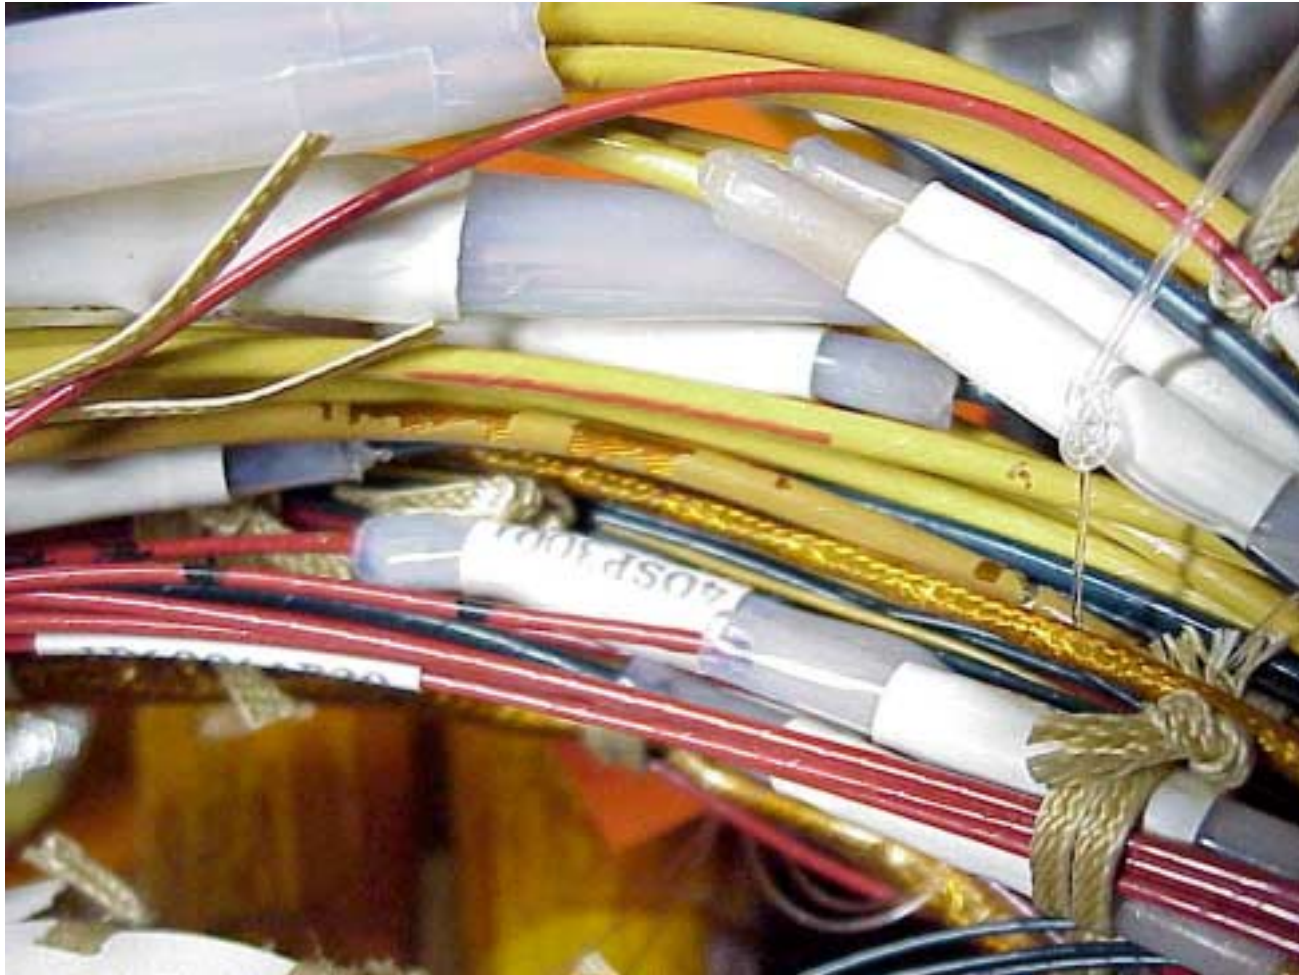
Types of Damage

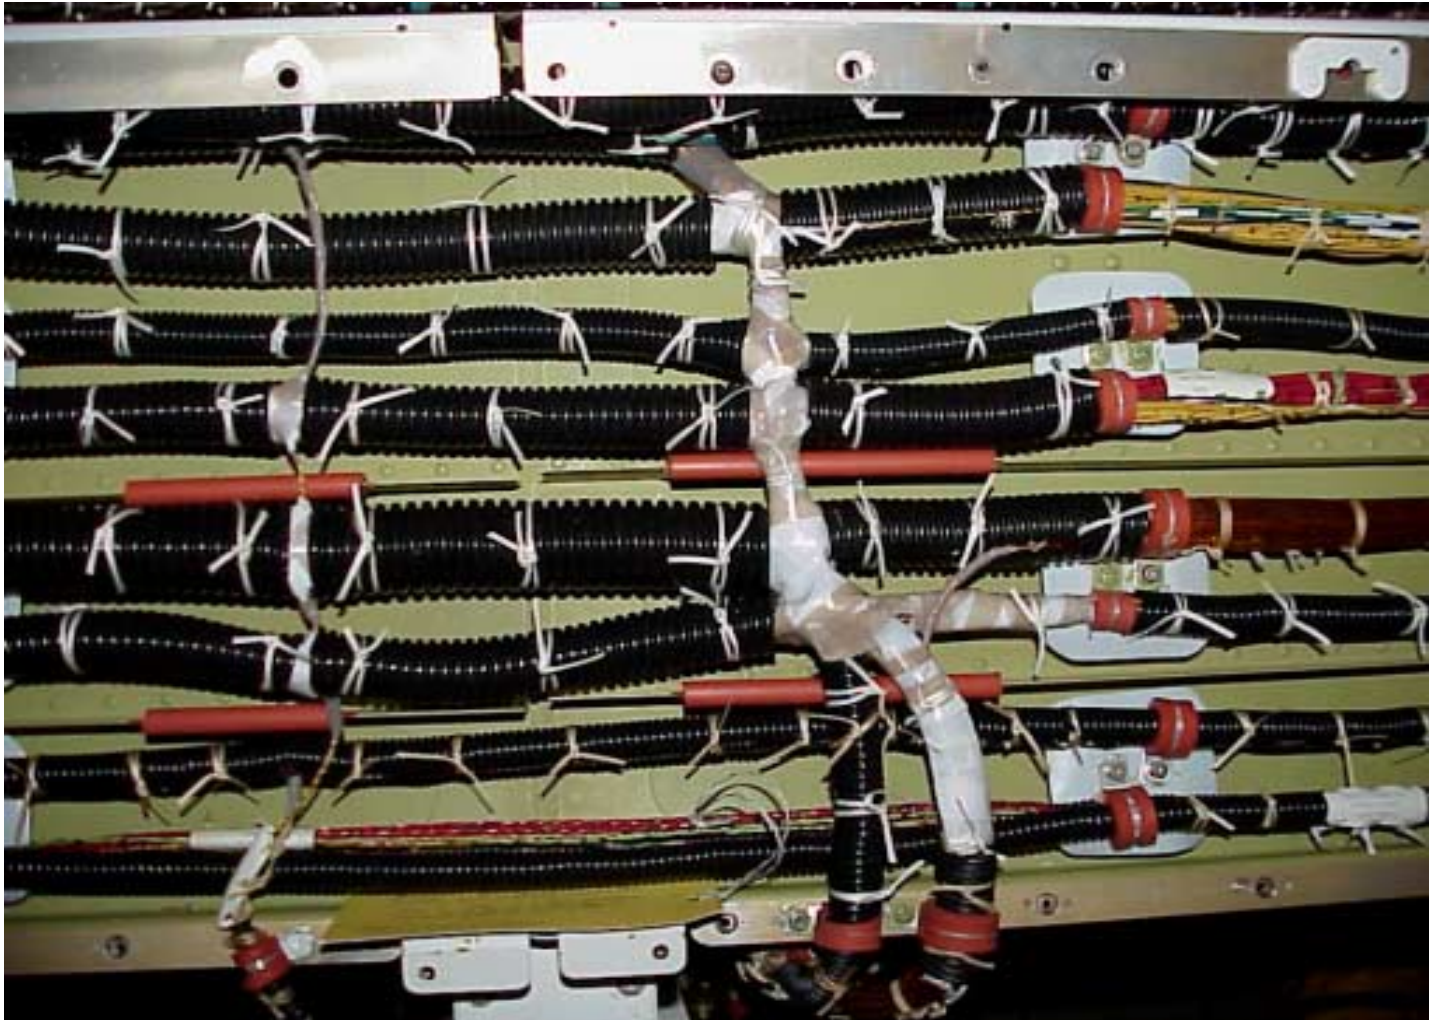
Convoluting Tubing

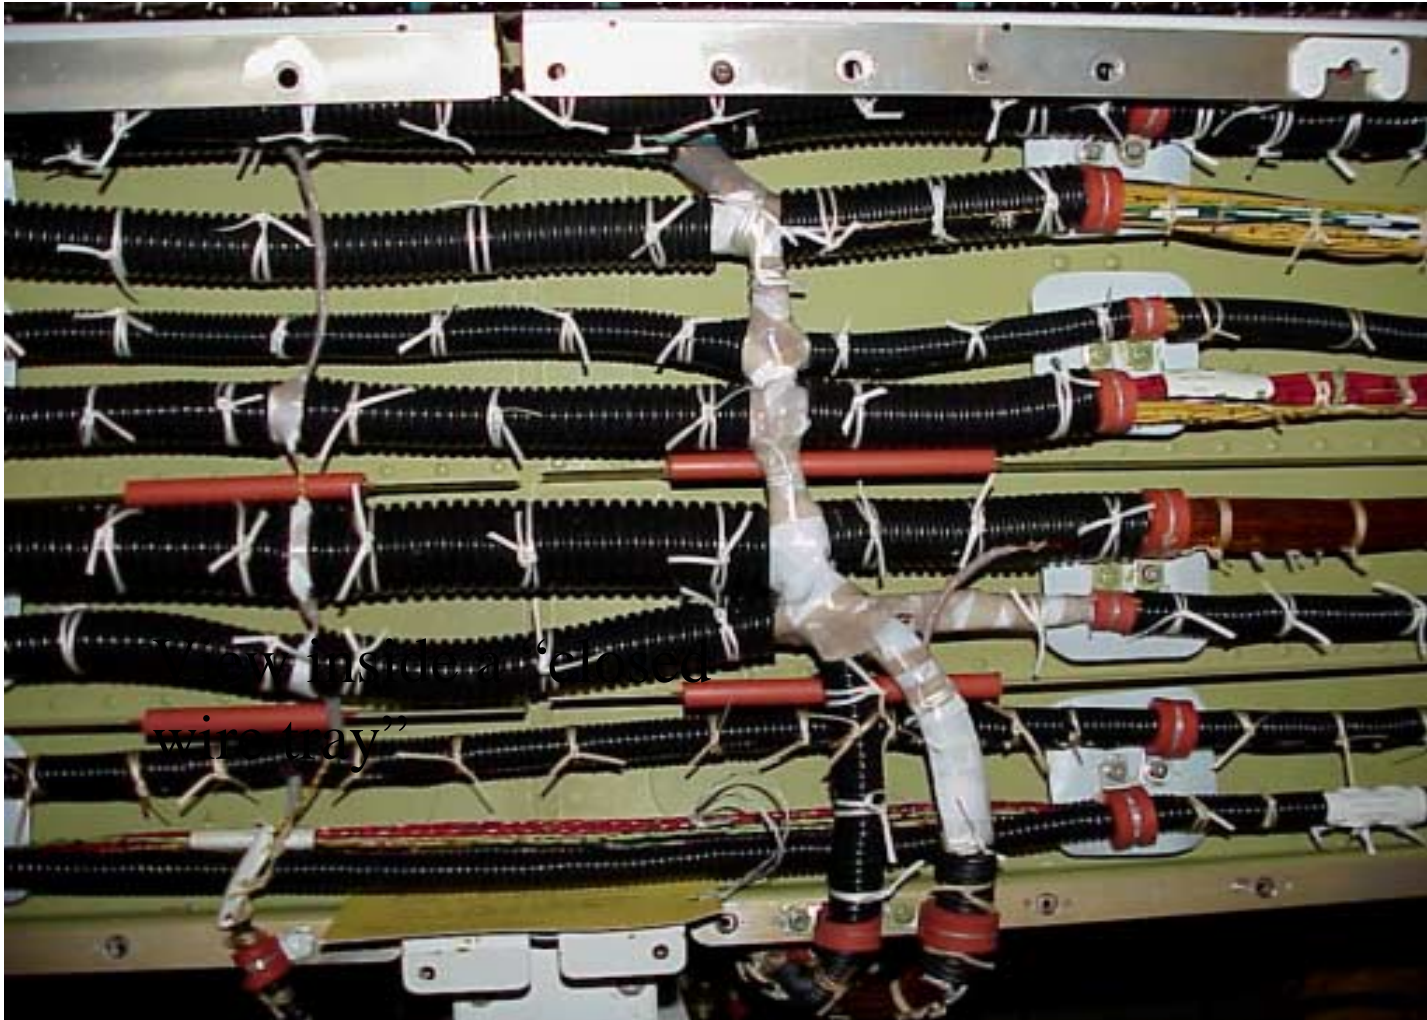
Wire Harness Separation Modification

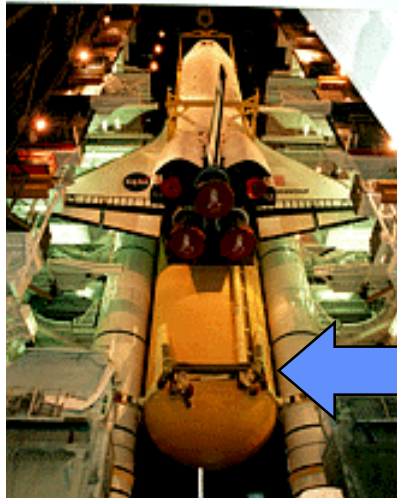
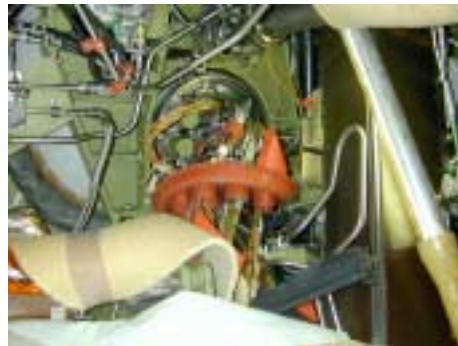
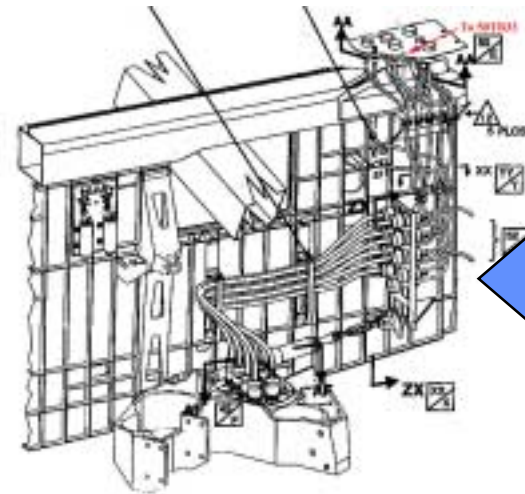
Orbiter/ External Tank Electrical Monoball Production Break

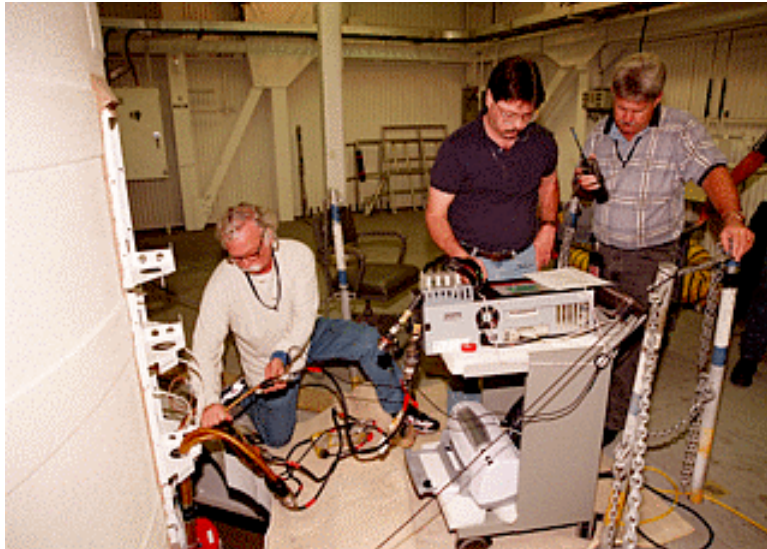
Repetitive Dielectric Withstanding Voltage (DWV) Study (Planned)

- **Effects of Repetitive DWV**

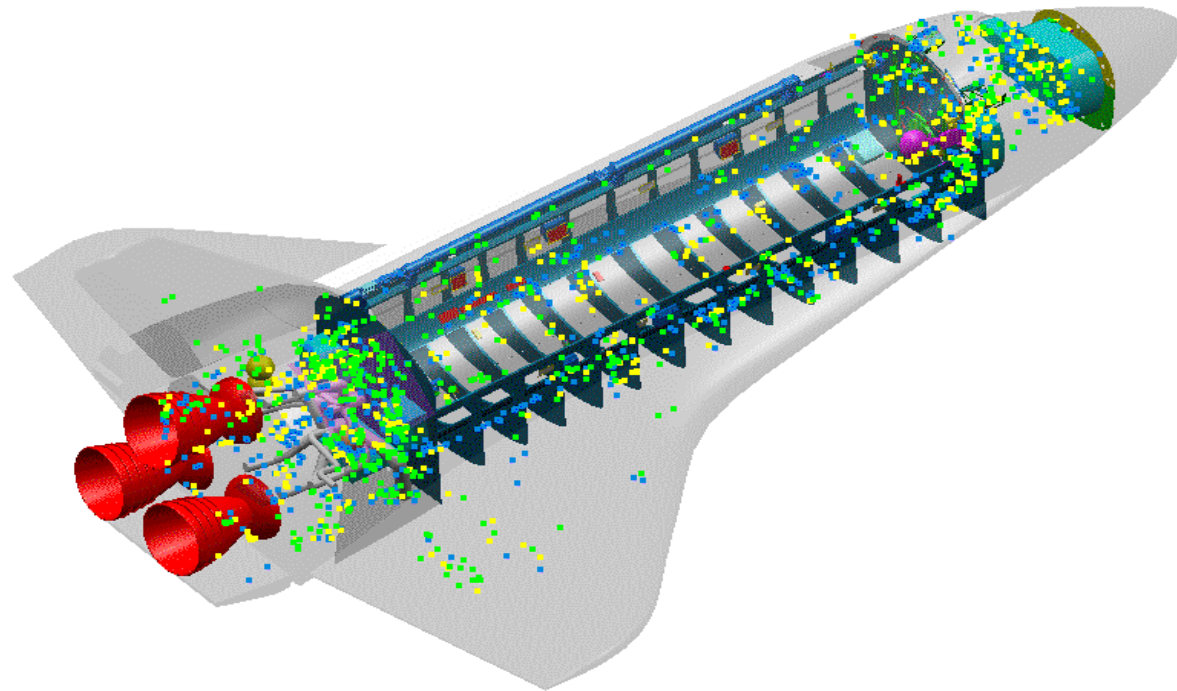
Wire Damage Mapping

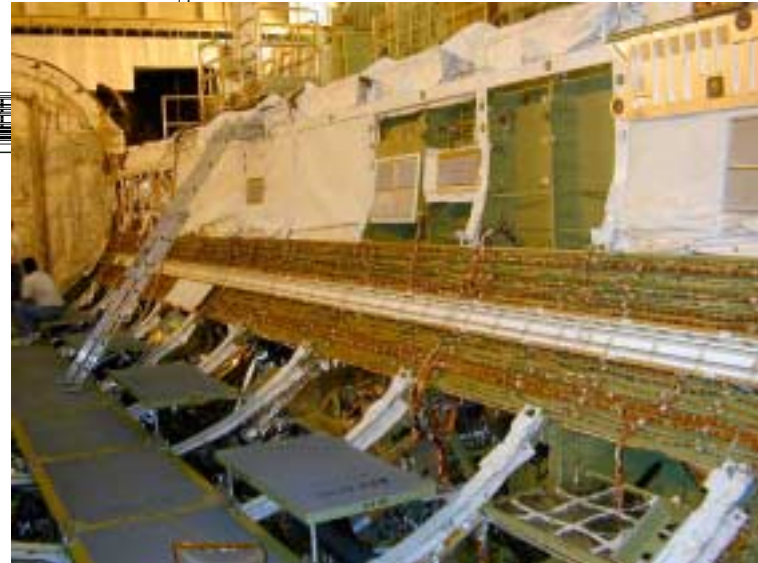
Wire Damage Mapping - Midbody

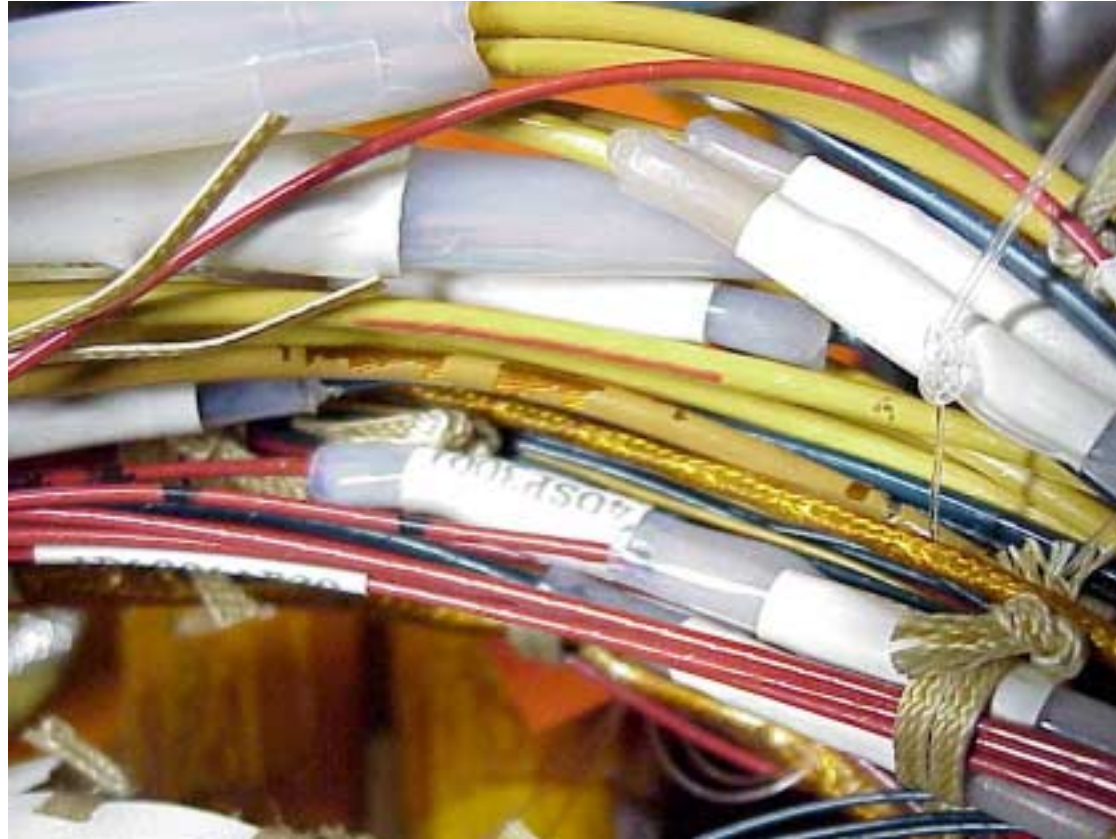
Standing Wave Reflectometry
